C0347 Cox's Walk Footbridge Assessment Report

London Borough of Southwark

Project Reference: 60493385
Project Number: C0347
60493385-C0347-REP-0003-A

23 May 2018

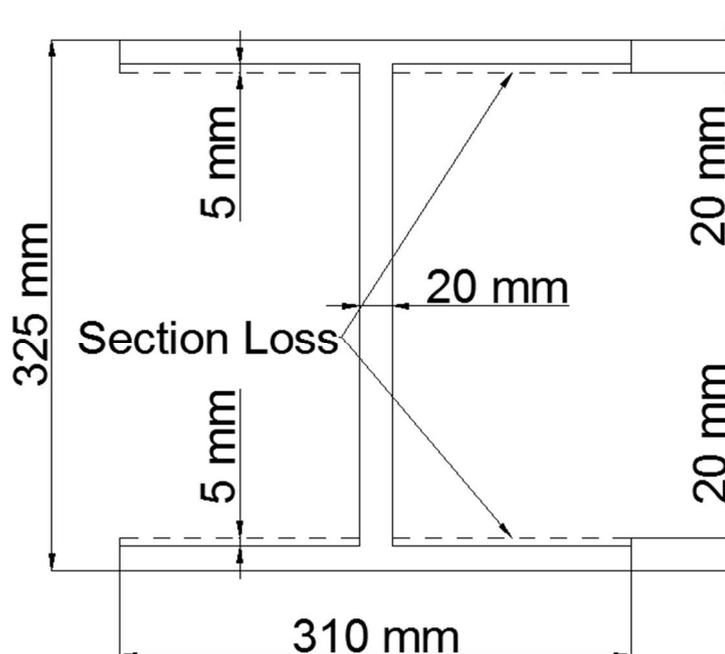
Figure 3: Cross section of steel beam with section loss

The inspection works undertaken by CA in February 2017 indicated cracks in the bridge abutments. Movement of bricks was also identified in the abutment walls. Hammer tapping of the bridge beams also identified a 5mm section loss to the bottom flange on the northern beam of the eastern span, close to the bearings

The steel beam was analysed with the 5mm section loss to in the inside of each flange observed in the Special Inspection Report (document: 60493385-C0374-REP-0002).

The steel beams pass the assessment. Treating and repainting is required to resist further corrosion as well as the introduction of waterproofing/drainage system to prevent moisture build up on steel girders at supports.

The proposed deck end screens in Appendix A would reduce further corrosion and water damage to the ends of the steel beams. The steel beams should be treated and repainted.

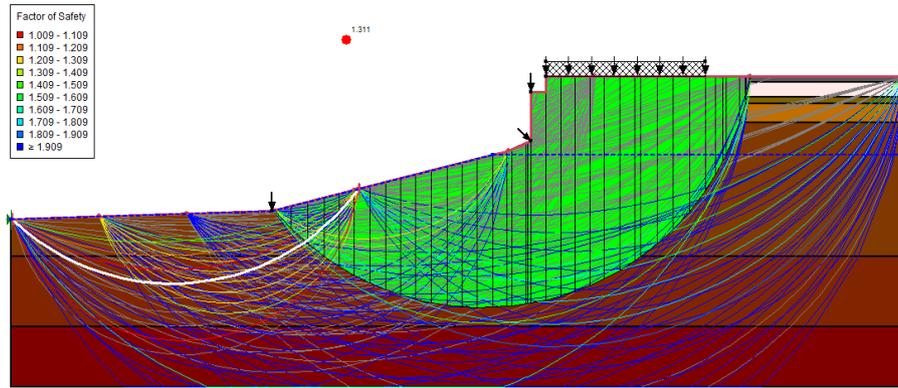
Figure 21: Critical Slip Failure Surface for East Abutment

Section	FoS	Figure Reference
East Abutment	1.31	Figure 21
East slope	1.06	Figure 22
West Abutment	1.21	Figure 23
West Slope	1.12	Figure 24

All factors of Safety (FoS) are above 1.0 for the parameters considered; and thus, there is no risk associated with global stability failure at both slopes of the footbridge.

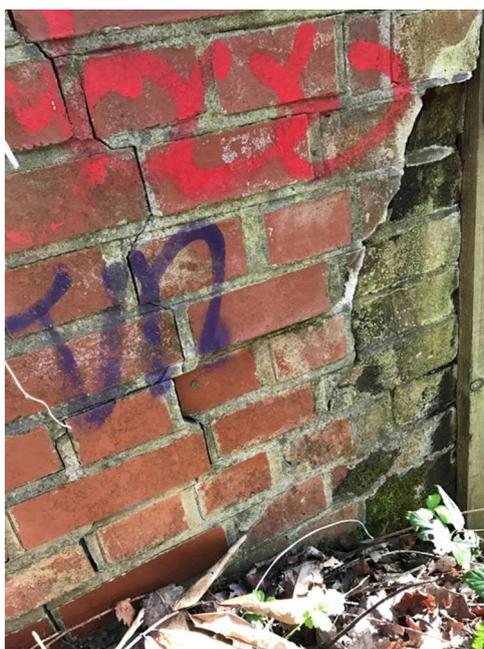
Figure 25: Cracking in western abutment south wall

As shown in Table 11 and Table 12, the assessment concludes that the front and side abutment walls cannot withstand the earth pressure and surcharge loadings even if they were repaired. The utilisation ratio shows that the bending stresses from lateral pressures are approximately 1.5 times the brickwork capacity for the front abutment wall and approximately 3.5 times the brickwork capacity for the side abutment walls.

Minor cracks with spalling masonry probably due to freeze thaw was observed in the 2015 Principal Inspection and Inspection for Assessment but this is not significant enough to have any effect on the structural integrity. This should be repaired.

Minor cracks and spalling of masonry should be patch repaired.

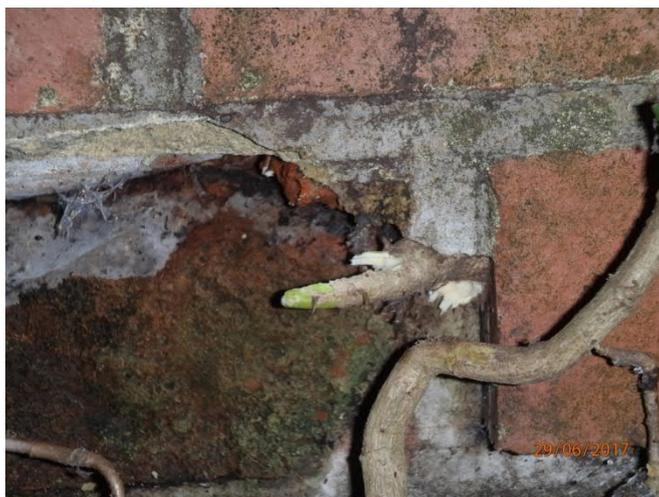
Figure 26: Rooting in the backfill of abutment observed during SI Report

In the SI Report (document: 60493385-C0347-REP-0002) a high presence of roots was found in the backfill of the abutments (Figure 26). It is likely a combination of rooting in the backfill and over utilisation of the abutment walls has resulted in the defects observed during the 2015 Principal Inspection and Inspection for Assessment Report.

Damage to the abutment walls is also caused by roots observed in the Special Inspection Report (604393385-C0347-REP-0002). Tree roots in the backfill need to be removed from behind the abutment walls to prevent further deterioration. This would provide an opportunity to replace the backfill with a lightweight material if required.
