## **Tustin Estate Low Rise Repairs**

### **Structural Repairs to Blocks of Flats**

**Ref:** 200535/J Ham

**Date:** 09 Aug 2021

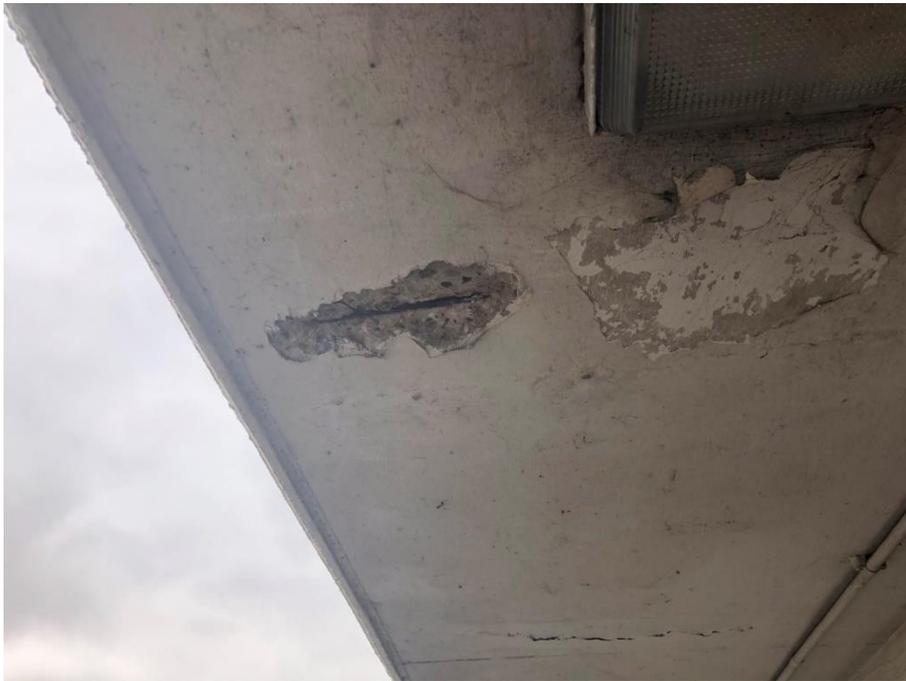
- external walkway soffits (see Photograph 1) and parapets
- downstand beams over window openings (see Photograph 2)
- concrete columns
- exposed slab edges
- roof level parapets.

Photograph 1 – Heversham House – spalling to soffits.

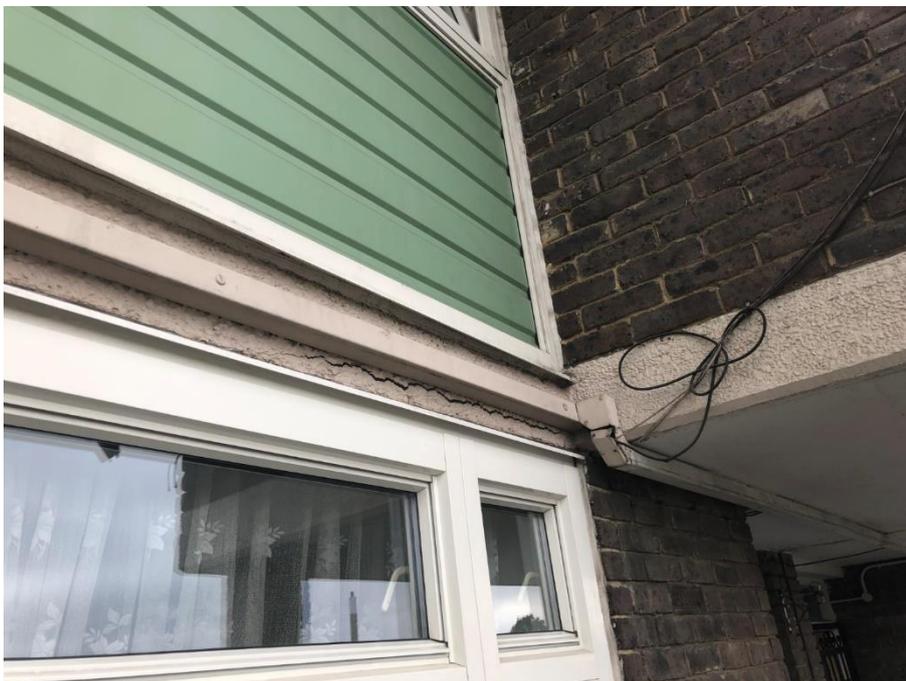
Photograph 2 – Heversham House – Spalling to downstand beams over window openings.

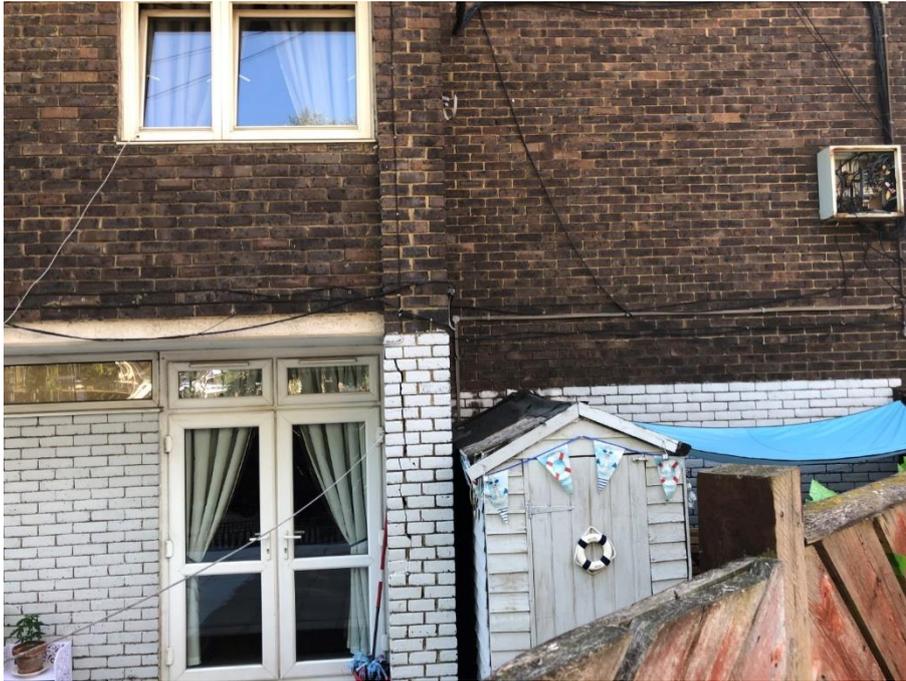
4.1.3 Brickwork nibs at party walls project to the rear elevation. In places there is vertical cracking through the nibs (see Photograph 3). This may result from differential thermal movement of the brick and concrete elements over the length of the building.

**Photograph 3 – Heversham House – Vertical cracking through brickwork nibs.**

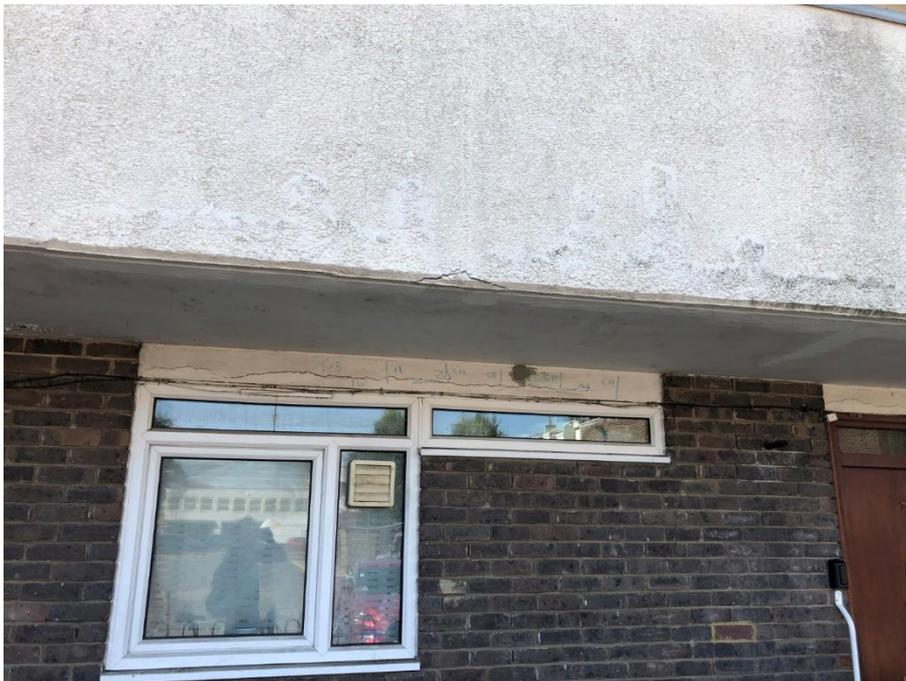
- cantilevered walkway soffits and parapets
- downstand beams over window openings (see Photograph 4)
- exposed slab edges
- spandrel panels below windows

**Photograph 4 – Kentmere House – Spalling to downstand beams over window openings.**

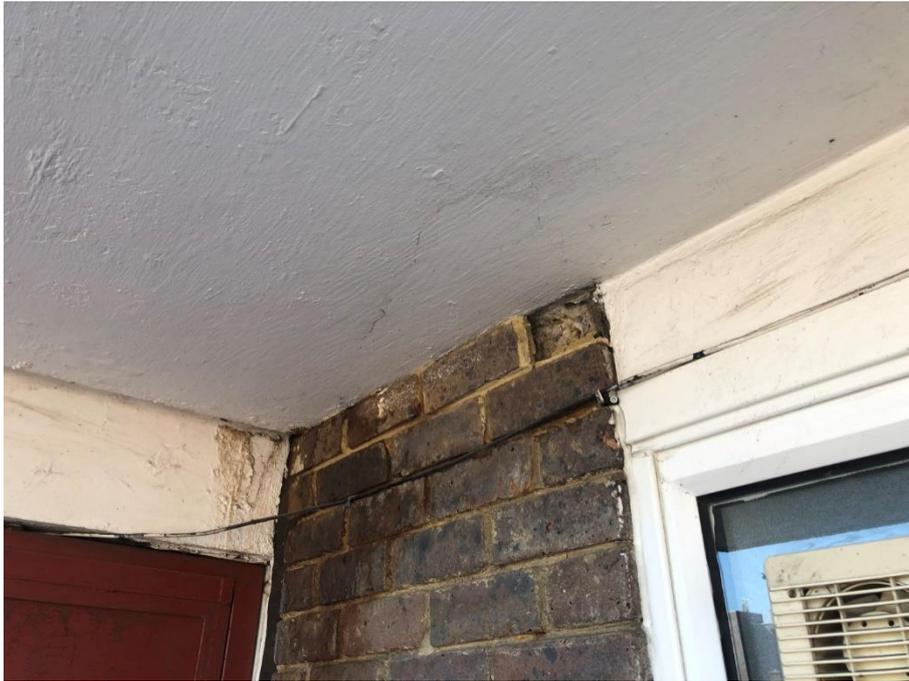
- 4.2.2 Pigmented coatings have been applied to all exposed concrete elements. The coatings are failing in places.
- 4.2.3 There are slip bricks covering concrete elements at the top of infill brickwork panels. In places the slip bricks have burst (see Photograph 5), possibly indicating concrete defects behind. It have also result from lack of a soft joint at the top of the brickwork and/or inadequate adhesion to the concrete behind.

**Photograph 5 – Kentmere House – Damage to slip bricks.**

5.5.2 Slip brick defects will require hammer tap surveys to identify loose and/or damaged units. Any underlying defects must be dealt with before slip bricks are re-applied. Slip bricks may be reused where in adequate condition, but replacement units are likely to be required. Suitable resin anchor systems should be used as required to restrain slip bricks, and a soft joint should be provided between slip bricks and the soffit above.

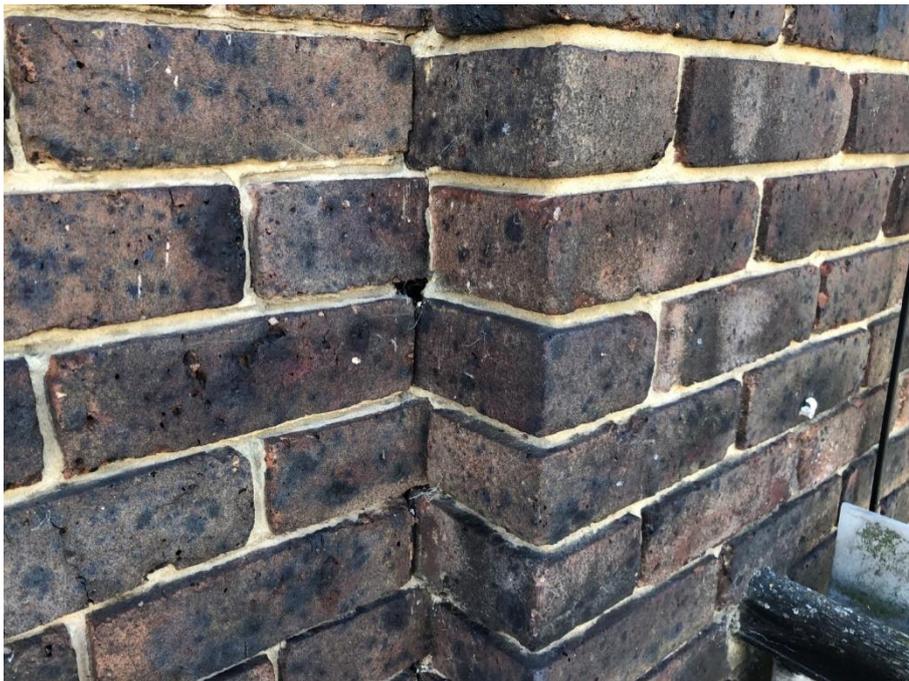
- 4.2.4 Cracking to brickwork and opening up of mortar joints at second floor level is visible from the clothes drying areas at second floor level (see Photograph 6). This may result from inadequate bonding of brickwork, differential movement of concrete and brickwork elements or a combination of the two factors.

**Photograph 6 – Kentmere House – Vertical cracking to external brickwork at second floor level.**

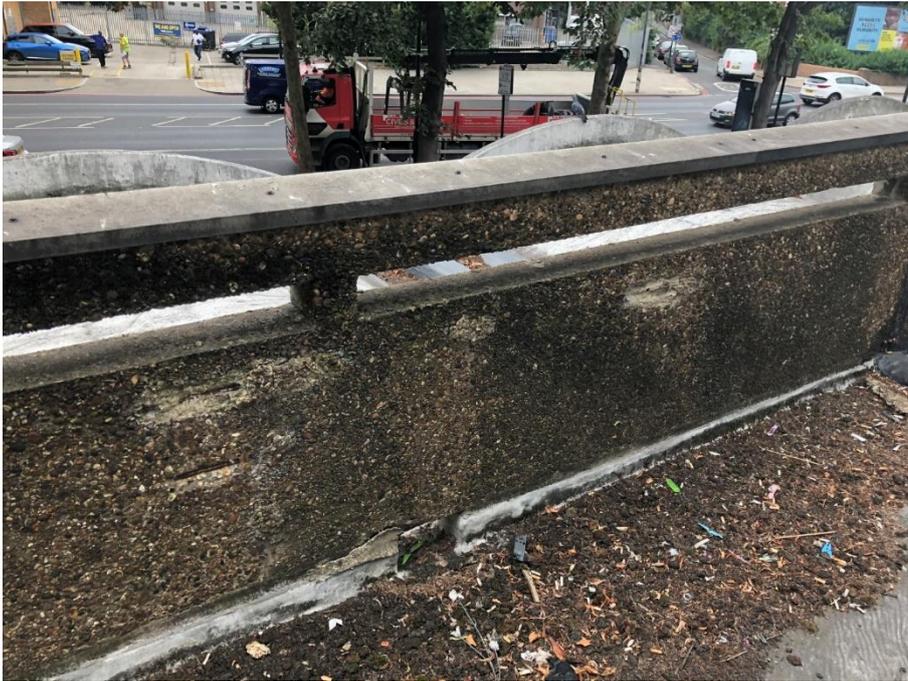
- parapets (see Photograph 7)
  - the external stair
  - shop front canopies (see Photograph 8)
  - concrete columns
  - RC external walls.
- 4.3.2 Previous concrete repairs have been carried out including recreation of exposed aggregate finishes. Repairs are failing which appears to be due to not having been carried out in accordance with best practice.

**Photograph 7 – Bowness House – Spalling to rear face of parapet over shop fronts.**

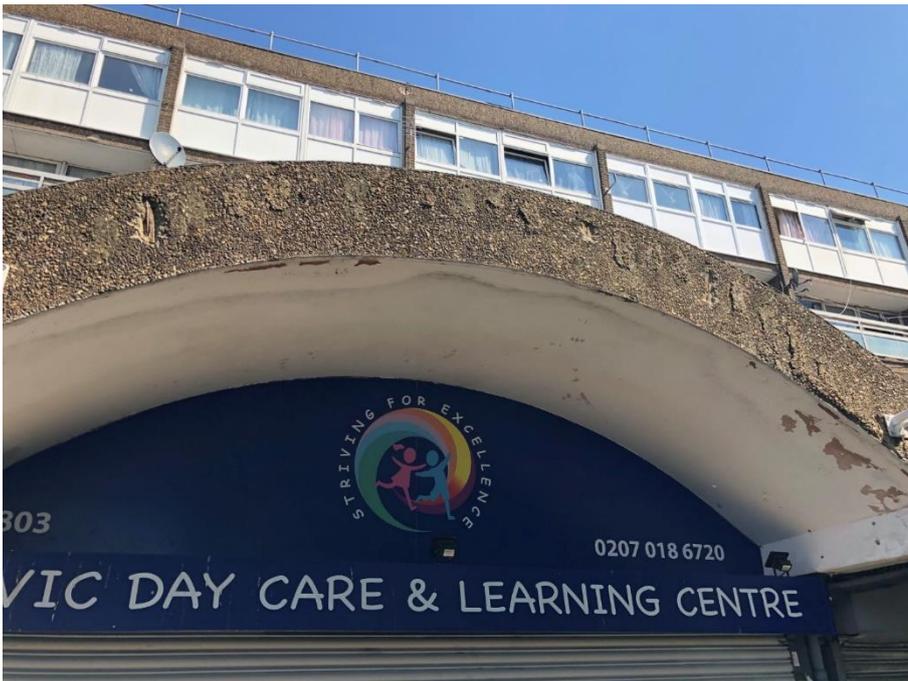
**Photograph 8 – Bowness House – Spalling to slender concrete upstand to shop front canopies.**

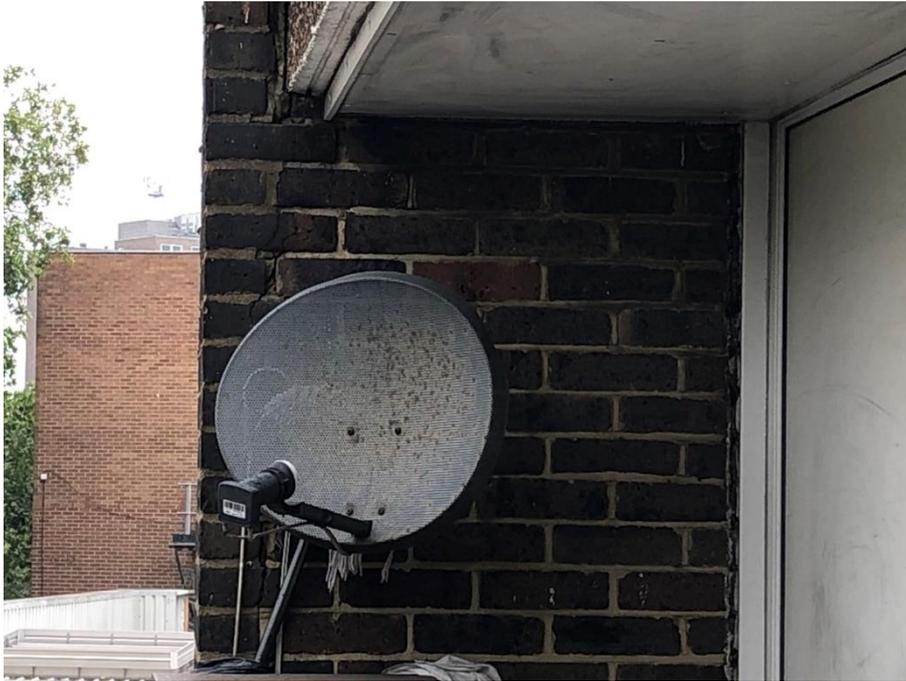
- 4.3.5 Brickwork nibs at party walls project to the front elevation. In places there is vertical cracking thought the front face and side faces of the nibs (see Photograph 9). This may result from deterioration of nearby concrete elements embedded in the brickwork.

**Photograph 9 – Bowness House – Vertical cracking to external brickwork at second floor level.**

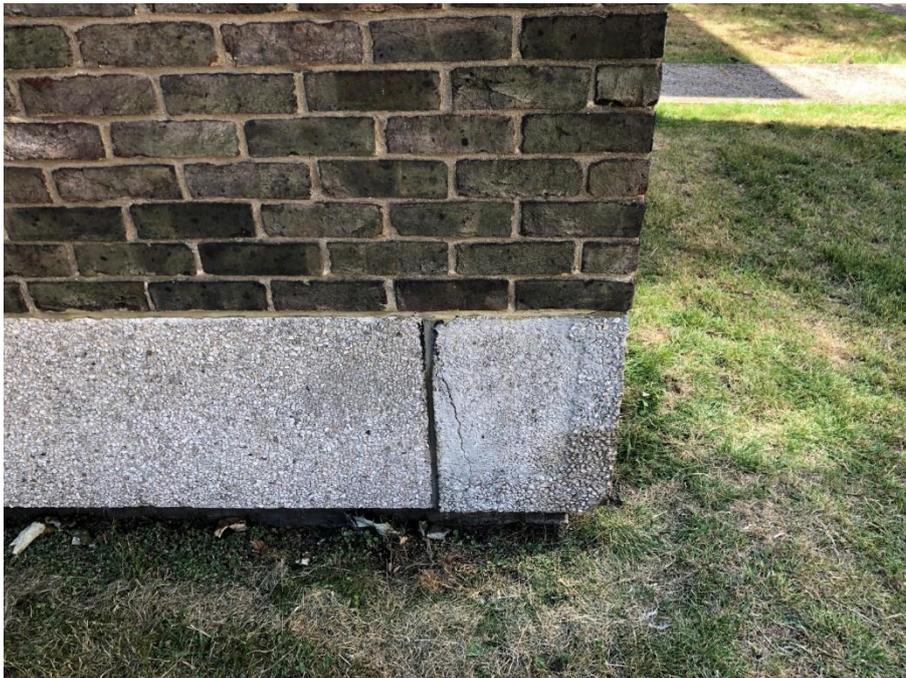
4.4.1 There is occasional spalling to the pre-cast concrete band elements (see Photograph 10).

**Photograph 10 – Typical concrete defect at Ullswater House and Hill Beck Close.**
