Ledbury Estate

Structural Assessment of Bromyard,
Peterchurch, Sarnsfield and Skenfrith
House

Issue 2 | 24 November 2017

Job number 245112-05

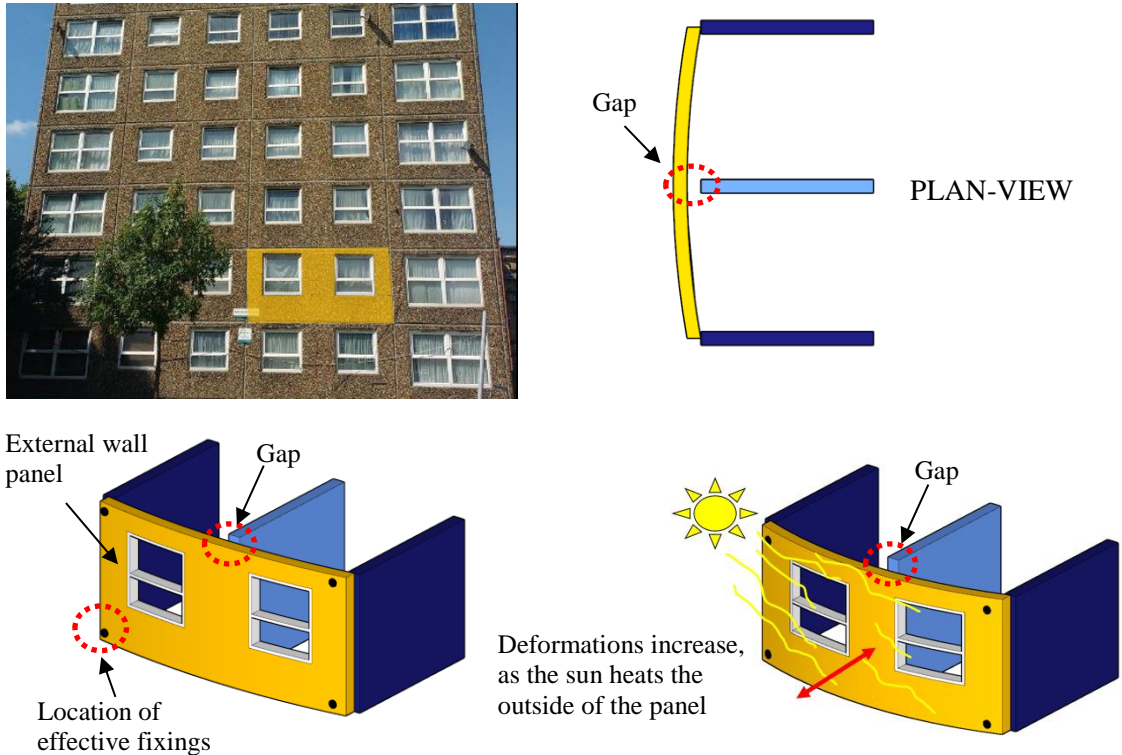
gaps to form over the full storey height between the centre of the bowed panel and intermediate cross-walls. Horizontal gaps also form between the external wall panels and the floor slabs. Additionally, temperature changes cause the gaps to further open/close, see Figure 7.

This is consistent with what has been reported by residents (gaps have been present for 17+ years and open and close depending on weather conditions) and is also consistent with gaps reported between the external wall panels and the internal walls in the 1985 BRE report [1].

Figure 7 Floor to ceiling vertical gap between the intermediate cross-walls and the external wall panels

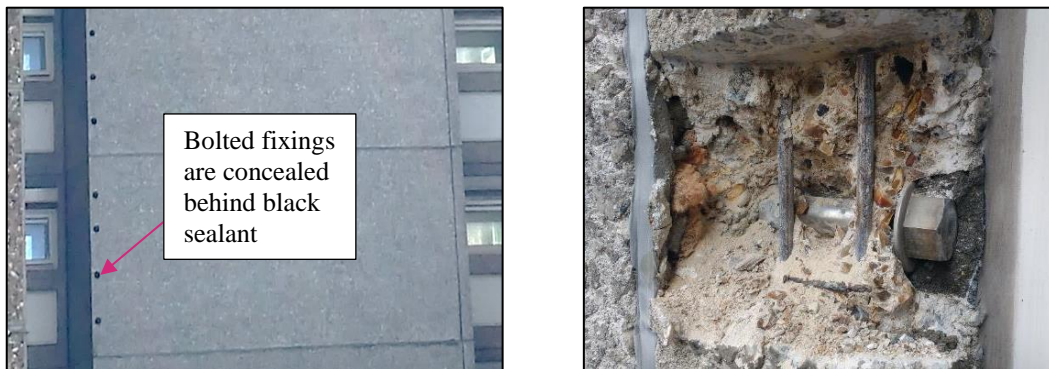
Three of the fixings bolts were exposed by breaking away the surrounding concrete, see Figure 10. These were exposed on Bromyard, Sarnsfield and Peterchurch House.

Stainless steel bolts, 34mm in diameter, sitting in slightly oversized holes (by 5-6mm) were exposed. The fixings and the surrounding reinforcement cage were found to be in very good condition, with no evidence of corrosion.

Figure 10 Fixings bolts are concealed behind black sealant (LHS). Fixing bolt exposed by breaking away surrounding concrete (RHS)

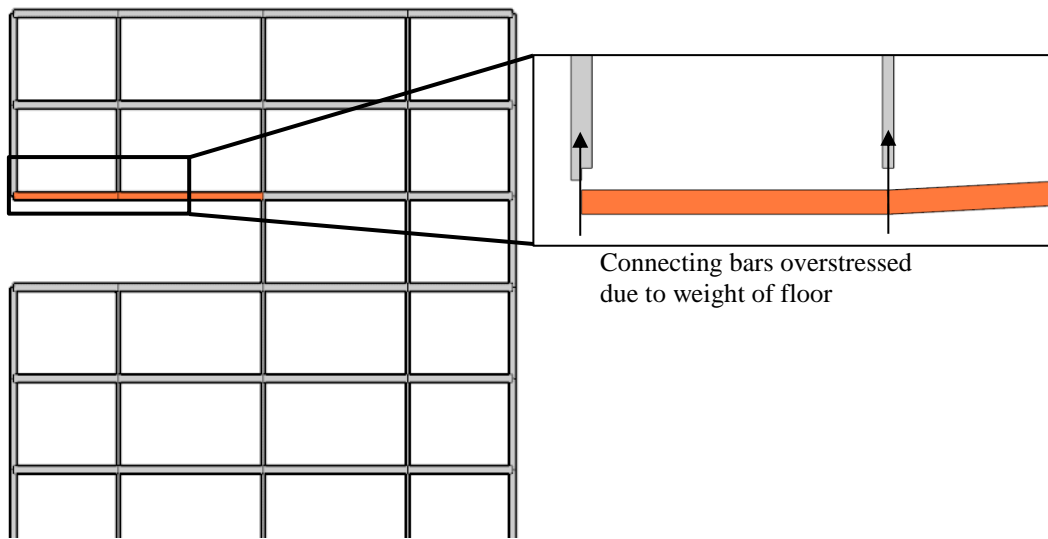
With the loss of the flank wall and the first internal wall, the floor on the level above the explosion will no longer have support from below and will try to vertically suspend from the wall above. Our investigations indicate that the floor slabs are connected to the wall below but are not directly connected to each other or to the wall above. Our investigations indicate that there are only two vertical bars per wall panel which continue from the wall panel to the wall panel above. The vertical bars are not capable of supporting the weight of the slab in tension and as such in the event of the wall failing below, then the floor previously supported by that wall would also collapse, see Figure 14. The area of the floor that would fail is greater than 15% of the total floor area (at that level) which is not compliant with the regulations for disproportionate collapse, see Figure 15.

Figure 14 With the loss of the flank wall and the first internal wall, the floor on the level above the explosion will no longer have support from below and will try to vertically suspend from the wall above. The connecting steel reinforcement bar would become overstressed due to the weight of the floor, leading to the tensile failure of this connection.
