## Contents

- 1.0 Introduction
- 2.0 Limitation and restricted areas
- 3.0 Building information
- 4.0 Inspection
- 5.0 Results of flat surveys
- 6.0 Common part information
- 7.0 Conclusion

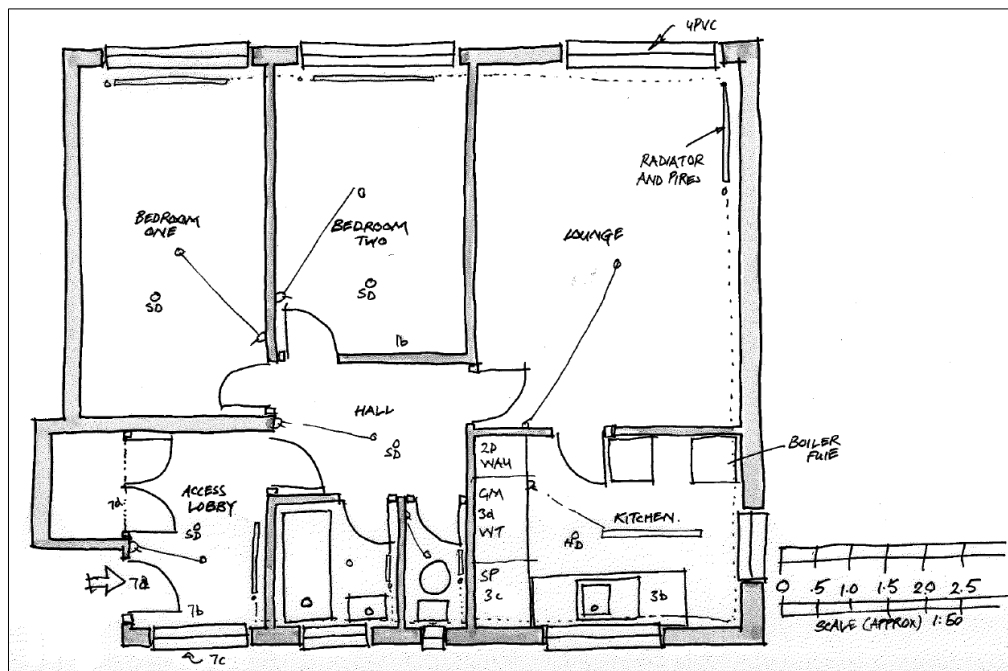
The following section provides a detailed description of each compartment; surveyed in a clockwise direction:

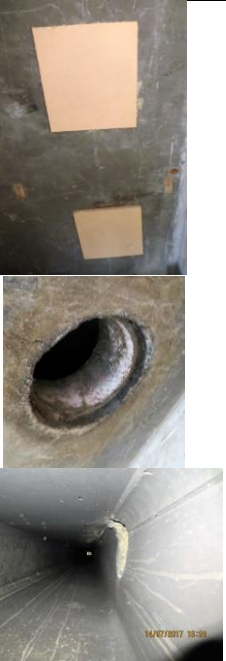
<p>unit; there are two circular holes that open to the concrete 'chimney'. These holes are in all flats above and below. Some have been covered with MDF where others are open.</p> <p>There is a vent grille into the protected hall. This is open and would have been used to allow warm air to travel into the hall.</p>	<p>equivalent fire resistance of the structure.</p> <p>Fire stop this area using appropriate material (ablative bat).</p>

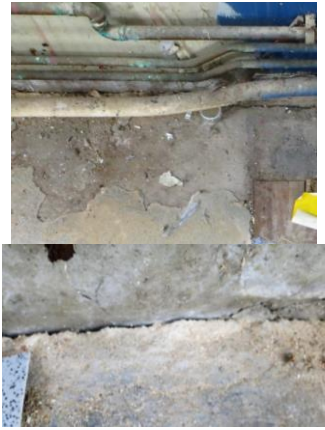
<p>c</p>	<p>The wall separating the kitchen from the water closet (W/C), the service and waste pipes enter the kitchen in to an enclosed duct. The pipe work was punched through the wall; it was covered with plaster and painted from the w/c side.</p> <p>A new gas supply pipe has been fitted externally, the pipe penetrates the external wall and then through the internal cupboard walls only. This has not been connected to the gas meter</p>	<p>The gap was filled with loose bricks, mortar and padded out with newspaper 'The Independent 1988'</p> <p>Access from the kitchen side is limited; also ACM is recorded in this area.</p>	<p>There are two solutions:</p> <ol style="list-style-type: none"> <li>1. replace the existing door to the w/c with a FD20 door, or</li> <li>2. hack off plaster (w/c side) and adequately fire stop the gaps</li> </ol>

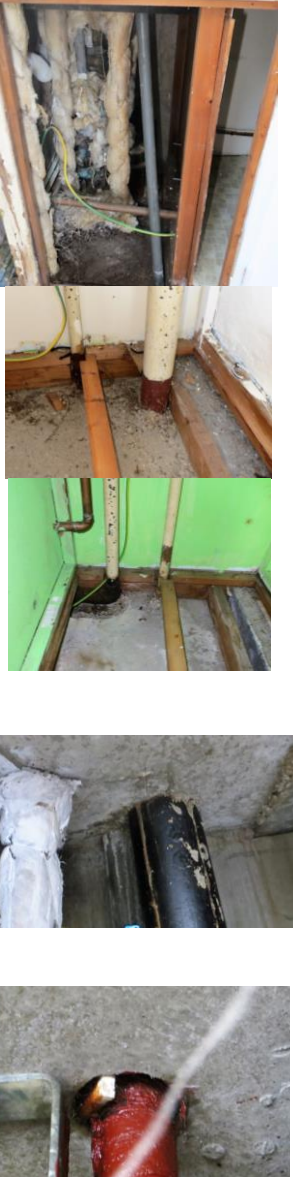
<p>The floors are sound with no loose concrete, however as only a sample was inspected other flats should be checked when they become available</p> <p>The ceiling was also checked, the majority of pipes where adequately sealed.</p>	<p>In another flat the gas pipe was fitted with a bend, to get this pipe installed the concrete floor was hacked back by at least 25mm.</p> <p>It was noted in one flat that the gas pipe penetrating the ceiling was not satisfactorily sealed.</p>	<p>The floor was not breached, as this pipe is now redundant it should be removed the area should be covered with a concrete mix.</p> <p>Pipework penetrating the ceilings should be fire stopped from the underside to reduce the risk of fire and smoke spread.</p>

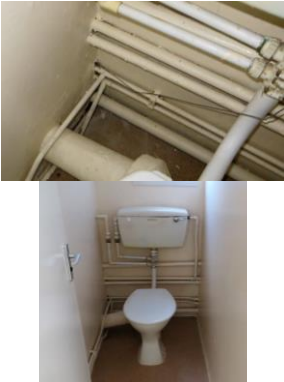
5	<b>Bathroom</b>	Access directly from the hall			
	a	<p><b>Floor and external wall junction</b> The bath panel was removed to expose a solid floor with no loose or friable concrete.</p>	<p>The junction between the floor and wall has a hairline gap, this would not be visible has it would covered by the bath panel or with a skirting board.</p> <p>A piece of paper folded was pushed through the gap to a depth 30mm.</p>	<p>When exposed the gaps should be sealed with a linear (flexible) fire rated sealant</p> <p>Further investigation may be required as part of the structural investigation</p>

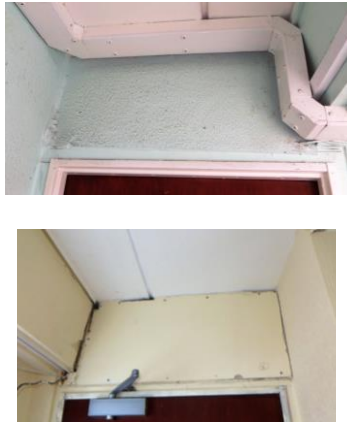
<b>b</b>	<p><b>Penetrations through the door frame</b></p> <p>The frame around the door has a metal casing, the area above the frame is timber.</p>	<p>Holes have been drilled through the frame to allow low voltage cables to penetrate the flat.</p>	<p>If the cables are no longer required, the holes are to be fire stopped, if are still needed cables are to be plugged with a fire and smoke resistant sealant to ensure the door and frame can restrict smoke and fire for at least 30minutes.</p> <p>The cavity identified (in the picture) must be sealed to prevent fire penetrating the breach and weakening the frame.</p>

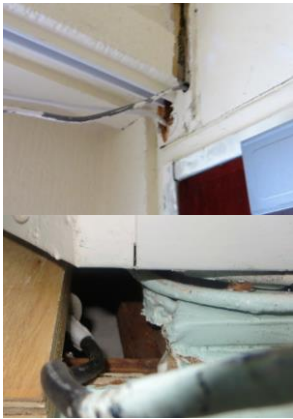
<b>c</b>	<p><b>Infill Panel</b></p> <p>The panel is located under the window in the access lobby.</p> <p>It is unknown if this panel is original,</p>	<p>A panel has been removed for testing, initial visual inspection: Polystyrene (dense) foam is sandwiched between aluminium panels.</p>	<p>This element is to be tested to classify the materials fire resistant properties.</p> <p>If the element fails to provide suitable</p>

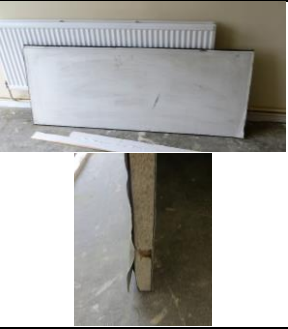
<p>although it may have been a Georgian Wired screen. However, as an unprotected area, it would not be permitted due to its dimensions and close proximity other unprotected areas.</p>		<p>resistance, it will be replaced with a panel system that provides similar resistance to the external walls.</p>

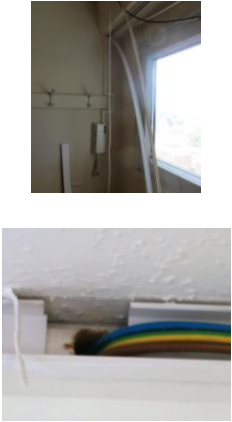
<p><b>e</b></p>	<p><b>Store cupboard</b>  The store cupboard has a footprint of 1.65m<sup>2</sup>. It has cables running at high level, which penetrates the doorframe as noted in section 4d.</p> <p>There are two types one appears to be communication (Coaxial) cables, that may be redundant; the others are lateral mains that enclosed in a plastic flexible conduit.</p> <p><b>Floor penetrations</b>  There is a metal box with 4 large cables penetrating the ground. The lino was removed and the floor was solid, with no visible signs of damage or being brittle, the area was hammer tested.</p> <p>The coaxial cable passes through the concrete floor with no sign of gaps.</p>	<p>The penetration from the common walkway (corridor) is fire stopped internally. The flexible conduit passes through the compartment (common parts and internal) wall for at least 20mm.</p>

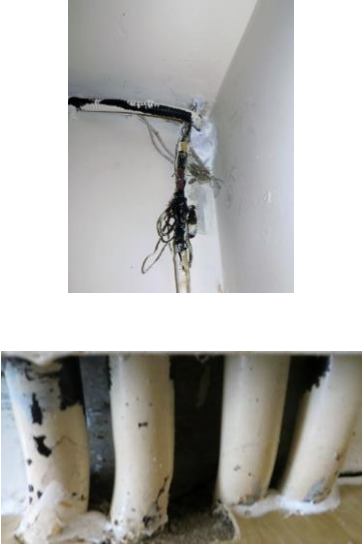
--	-----------------	--	---	--	---
