**Project Reference:** SE1920-1151

This letter report provides the background, methodology, findings and subsequent recommendations made, following the bat tree assessment carried out at Cox's Walk, Sydenham Hill Woods, Southwark on 6<sup>th</sup> November 2019.

**Table 1:** Ground-based and Climbed Tree Inspection Results

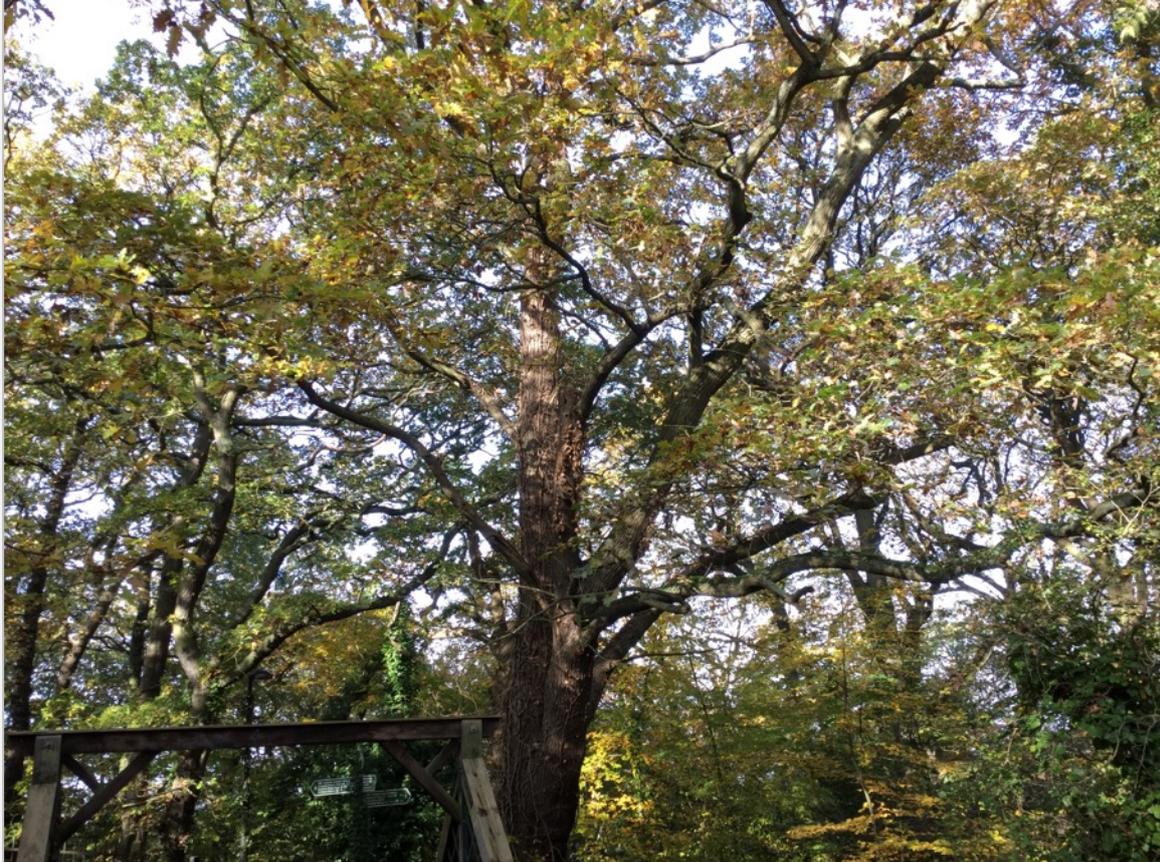
**TREE: T001**

**Bat Roost Potential:** Low

**Potential Roost Type:** Occasional

Tree T001 contained six Potential Bat Roosting Features, three of which were assessed as having negligible potential to support roosting bats (PRF-A, PRF-B and PRF-D); and, three as having low potential to support roosting bats (PRF-C, PRF-E and PRF-F). T001 was therefore assessed as having low potential to support roosting bats.

In summary, the Cox's Walk Bridge Oaks had low potential to support bats and may therefore be felled under the supervision of an ecologist and immediately following a close inspection carried out by a licensed bat ecologist. The bat boxes should be moved to suitable locations on mature trees in the surrounding area and two replacement oak samplings planted following the completion of the works.

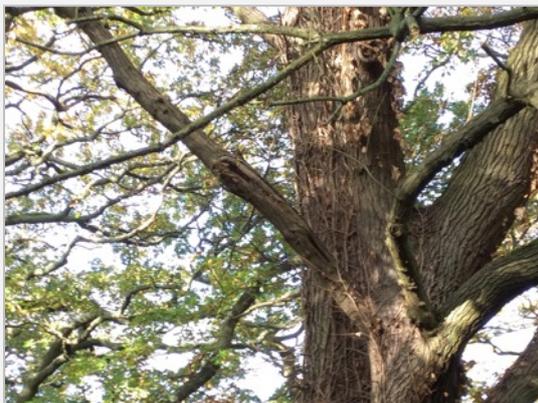
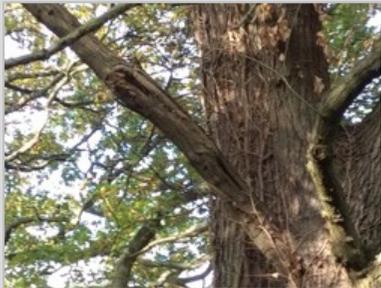
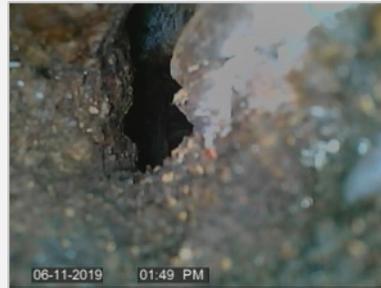
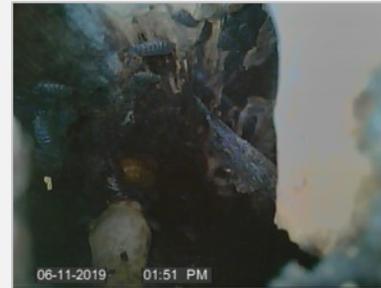
**T001-PRF-A**

**Type:** Tear-out

**Location:** Limb

**Height:** 3.75m

**Bat Roost Potential:** Negligible

**Rationale:** Superficial ingress and presence of competitors (spiders and slugs).

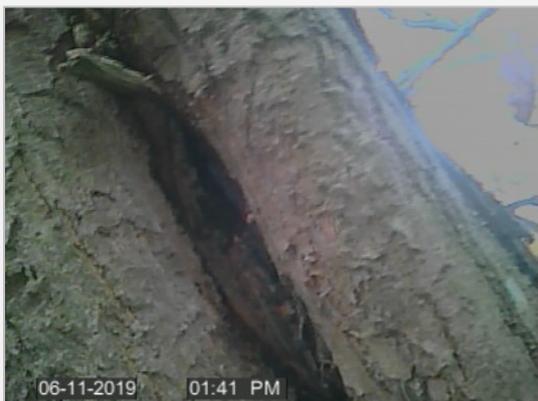
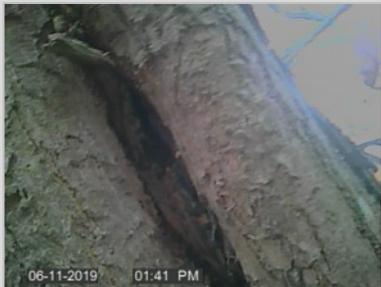
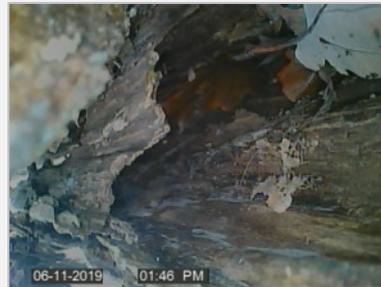
**T001-PRF-B**

**Type:** Tear-out

**Height:** 8.5m

**Bat Roost Potential:** Negligible

**Rationale:** Superficial ingress.

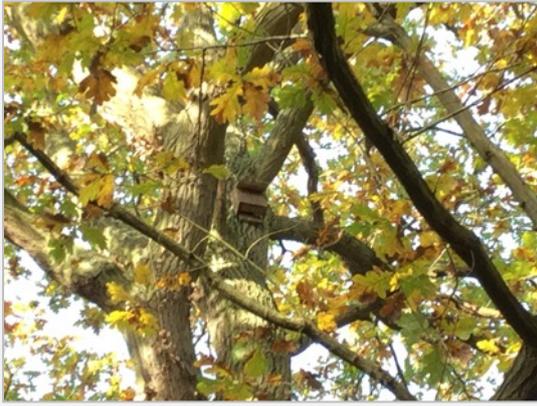
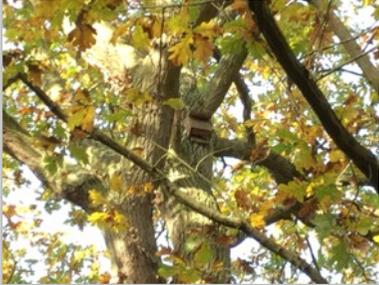
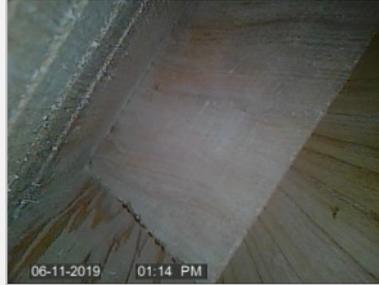
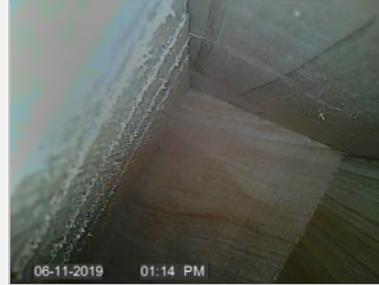
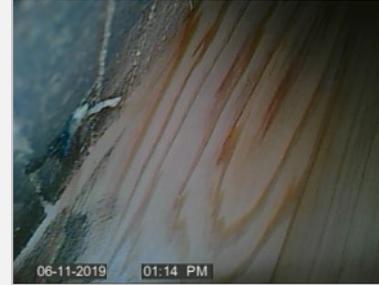
**T001-PRF-C**

**Type:** Bat box

**Bat Roost Potential:** Low

**Rationale:** Empty, with one bird dropping. Could be occupied at a later date but no evidence of past occupation at time of survey.

There is, however, a very low residual likelihood that individual bats may have found and utilised these features to roost between the time of the last inspection and the time of the works. As a precautionary approach, it is therefore recommended that the removal of these features is supervised by an ecologist and should be immediately preceded by a close inspection carried out by a licensed bat ecologist.

Two features within the trees (T001-PRF-C and T002-PRF-A) are bat boxes, it is therefore recommended that these are moved to suitable locations on nearby mature trees. Following removal from the trees the bat boxes should be repositioned in suitable locations under the guidance of the ecologist supervising the works.

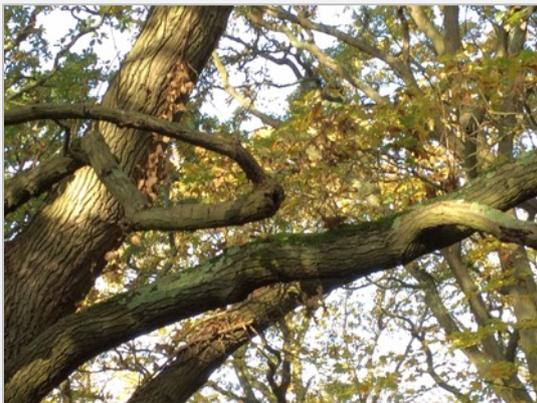
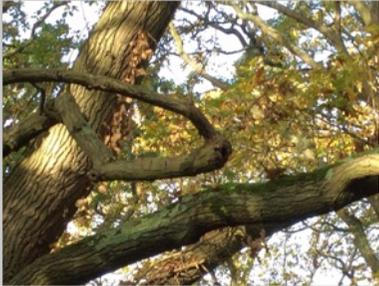
**T001-PRF-D**

**Type:** Knot-hole

**Bat Roost Potential:** Negligible

**Rationale:** Small crevice filled with a slug and damp debris. Insufficient ingress for bats.

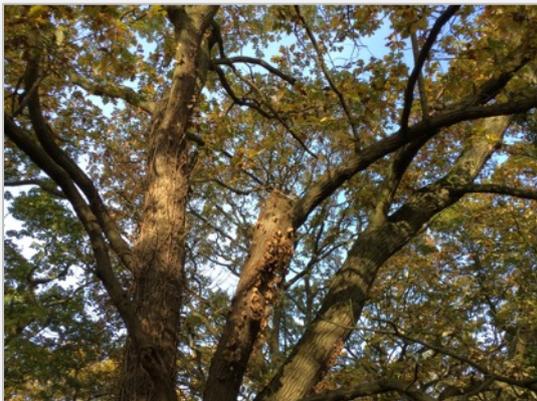
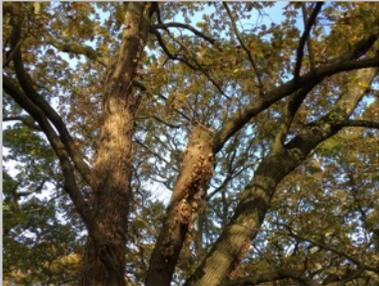
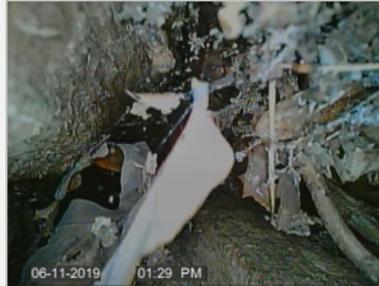
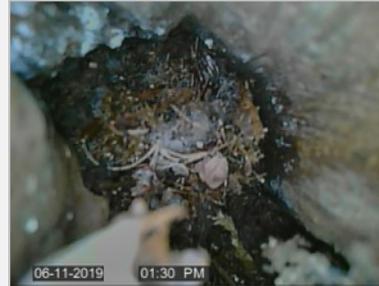
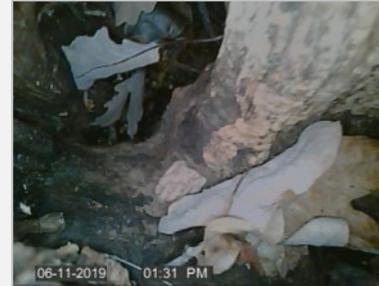
**T001-PRF-E**

**Type:** Pruning-cut

**Bat Roost Potential:** Low

**Rationale:** Open at top to light and rain. Partially full of leaves but some clean, dry spaces. Defunct bird nest / scrape at the base.

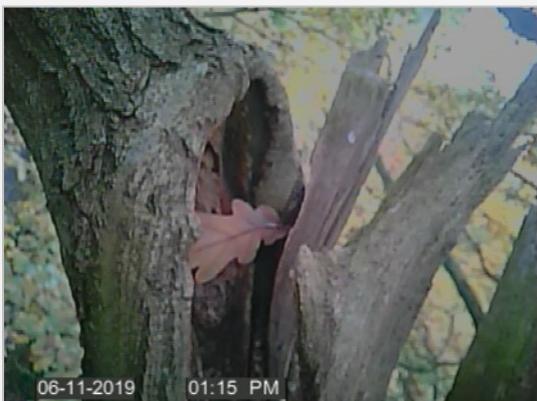
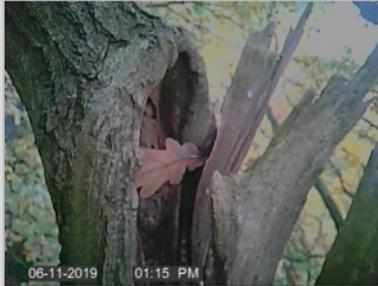
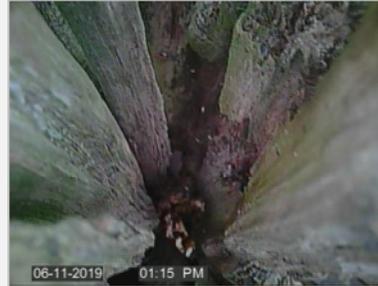
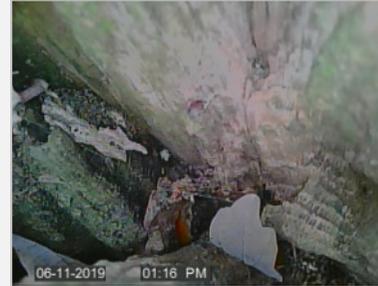
**T001-PRF-F**

**Type:** Transverse-snap

**Bat Roost Potential:** Low

**Rationale:** Generally open and exposed with one, dry, wedge-shaped space between bark and heartwood. Too exposed to support bats.

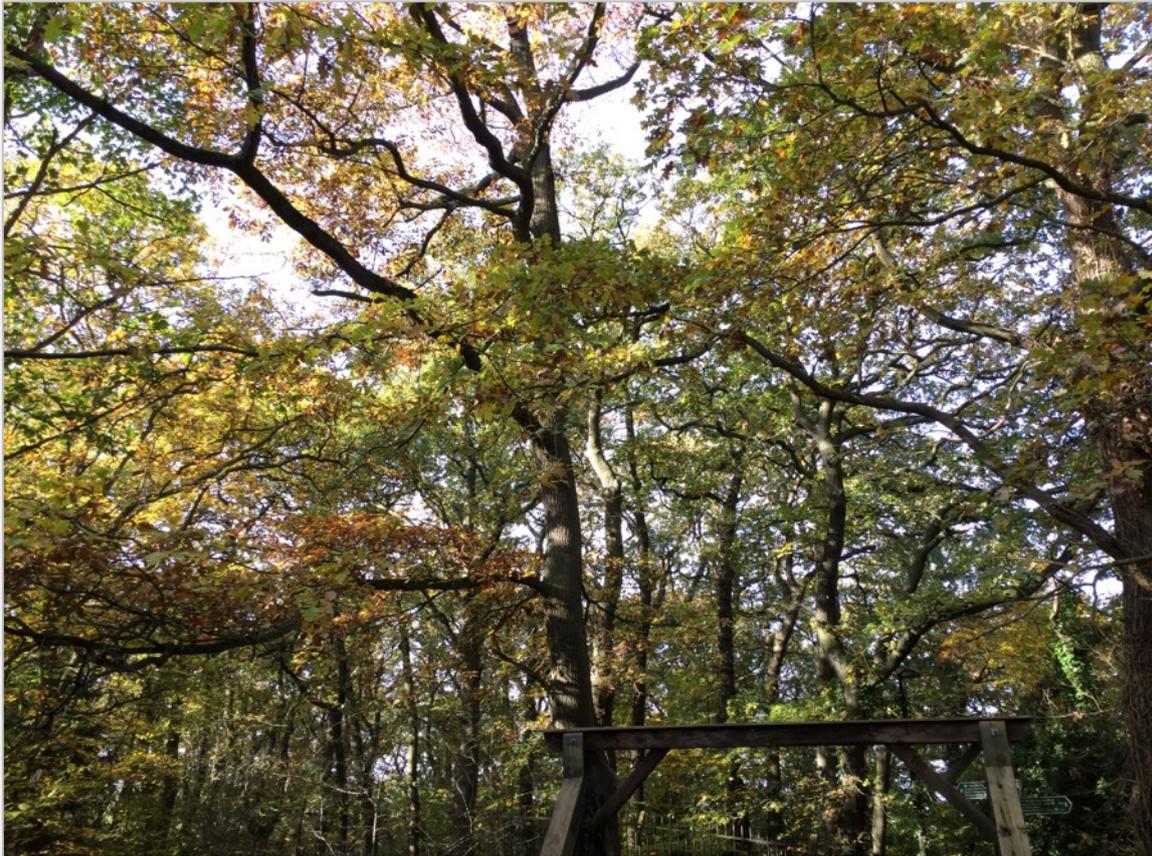
**TREE: T002**

**Bat Roost Potential:** Low

**Potential Roost Type:** Unknown

Tree T002 contained one Potential Bat Roosting Feature (PRF-A) which was assessed as having low potential to support roosting bats.

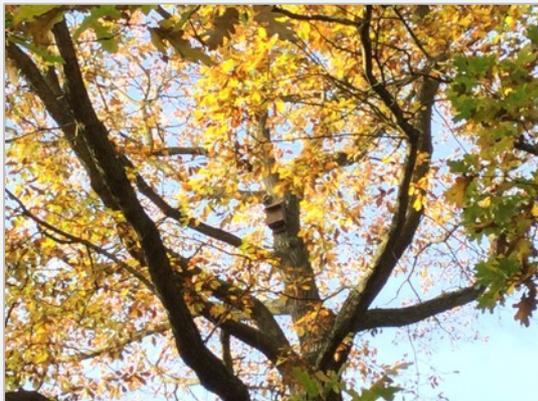
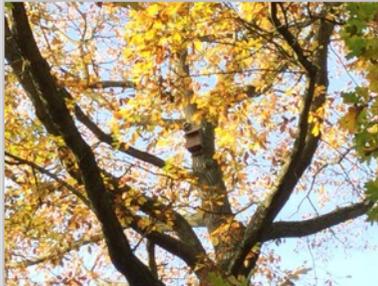
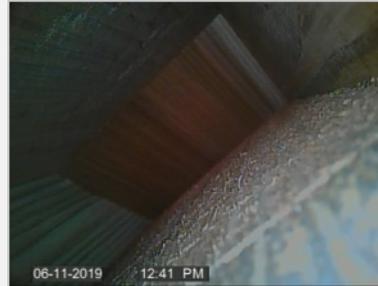
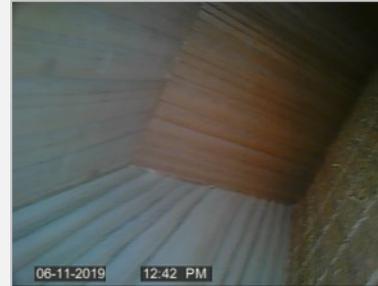
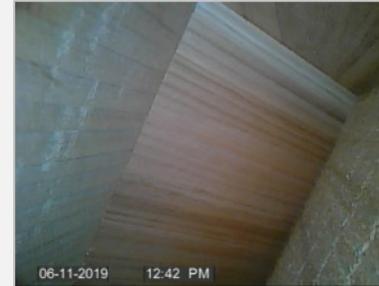
**T002-PRF-A**

**Type:** Bat box

**Bat Roost Potential:** Low

**Rationale:** Empty and clean. No sign of past habitation by bats or birds although birds seen intermittently visiting to forage.
