ARBORICULTURAL IMPACT ASSESSMENT REPORT FOR:

Cox's Walk Footbridge

Sydenham Hill Wood

Ref: SFO/CWF/AIA/01b

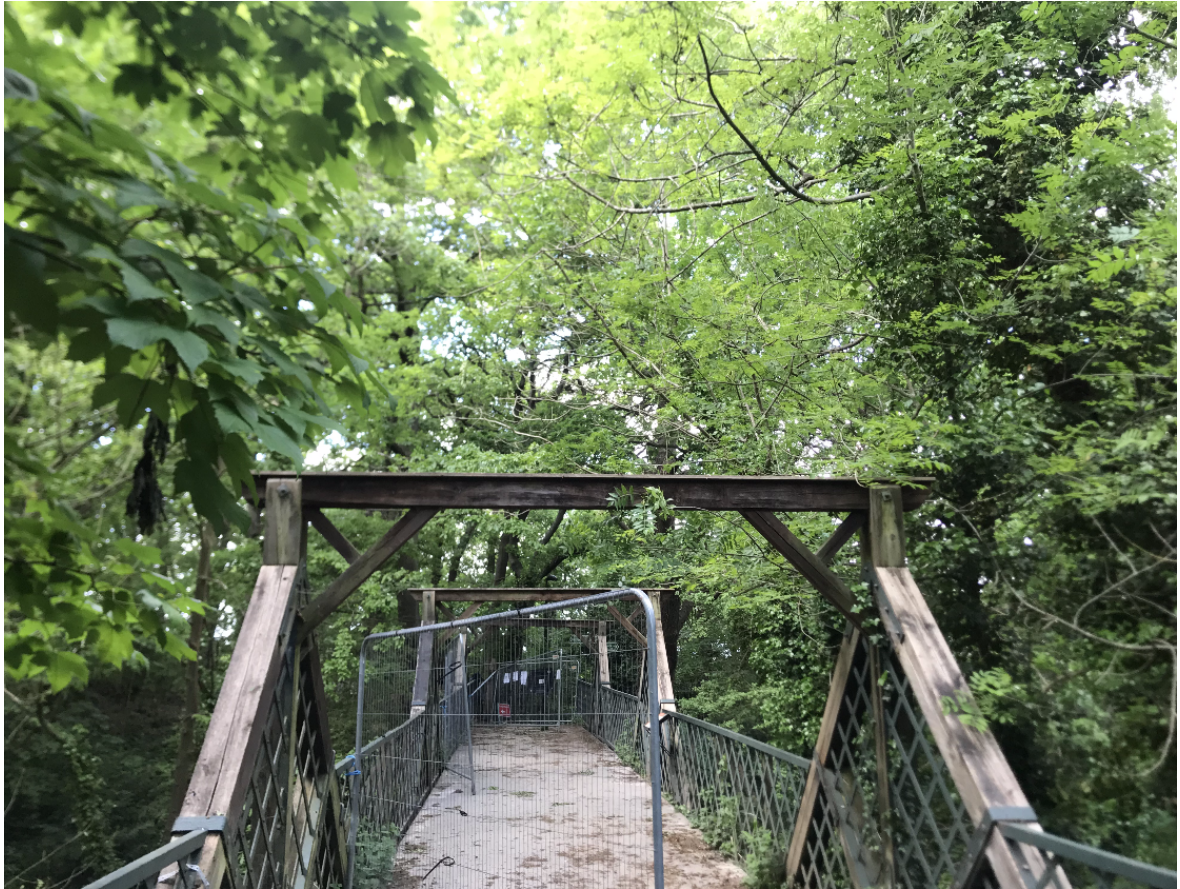
Photograph 1: Cox's Walk Footbridge

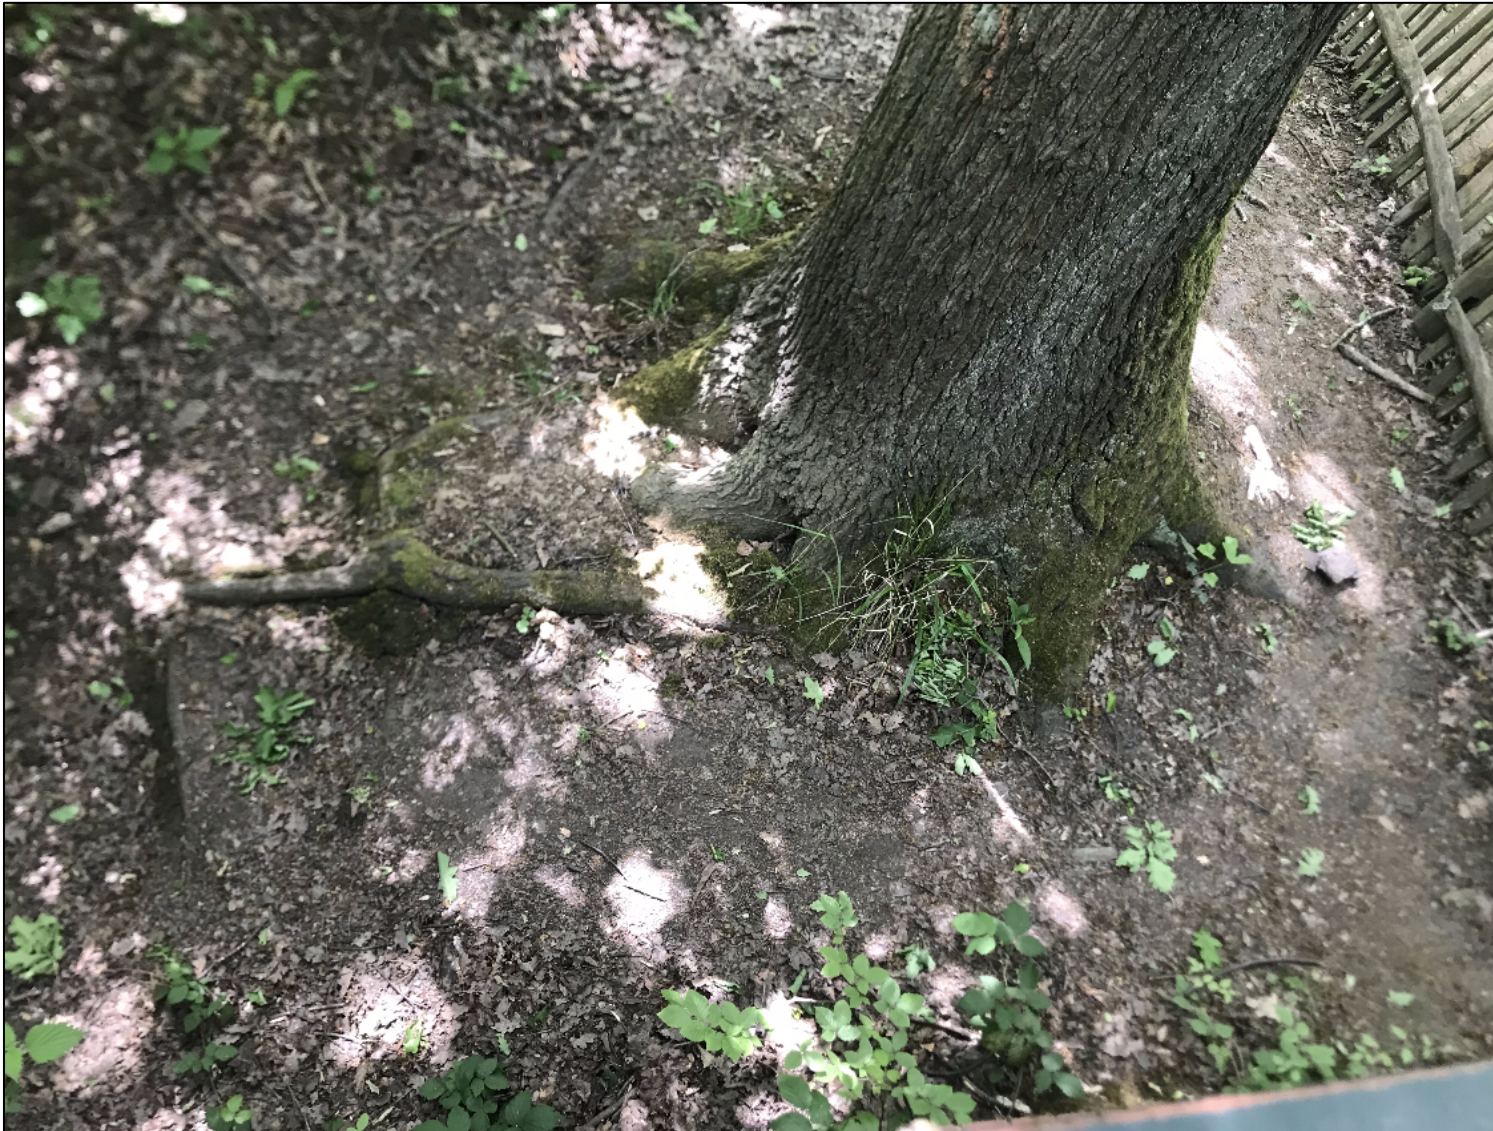
- 3.2.1 Both subject trees are English oaks (*Quercus robur*). I would concur with the findings of the AECOM Arboricultural Technical Note with regard to their quality and that document's assessment of their age.
- 3.2.2 During my site visit I observed that each tree's gross buttress architecture and visible rooting was predominantly away from the existing abutment (see Photographs below). This would correspond with the relative age of the structure and trees and indicates that the area beneath the existing abutment is not being used significantly by either tree.

Photograph 2: Root architecture trending away from abutment with surface root running parallel to it

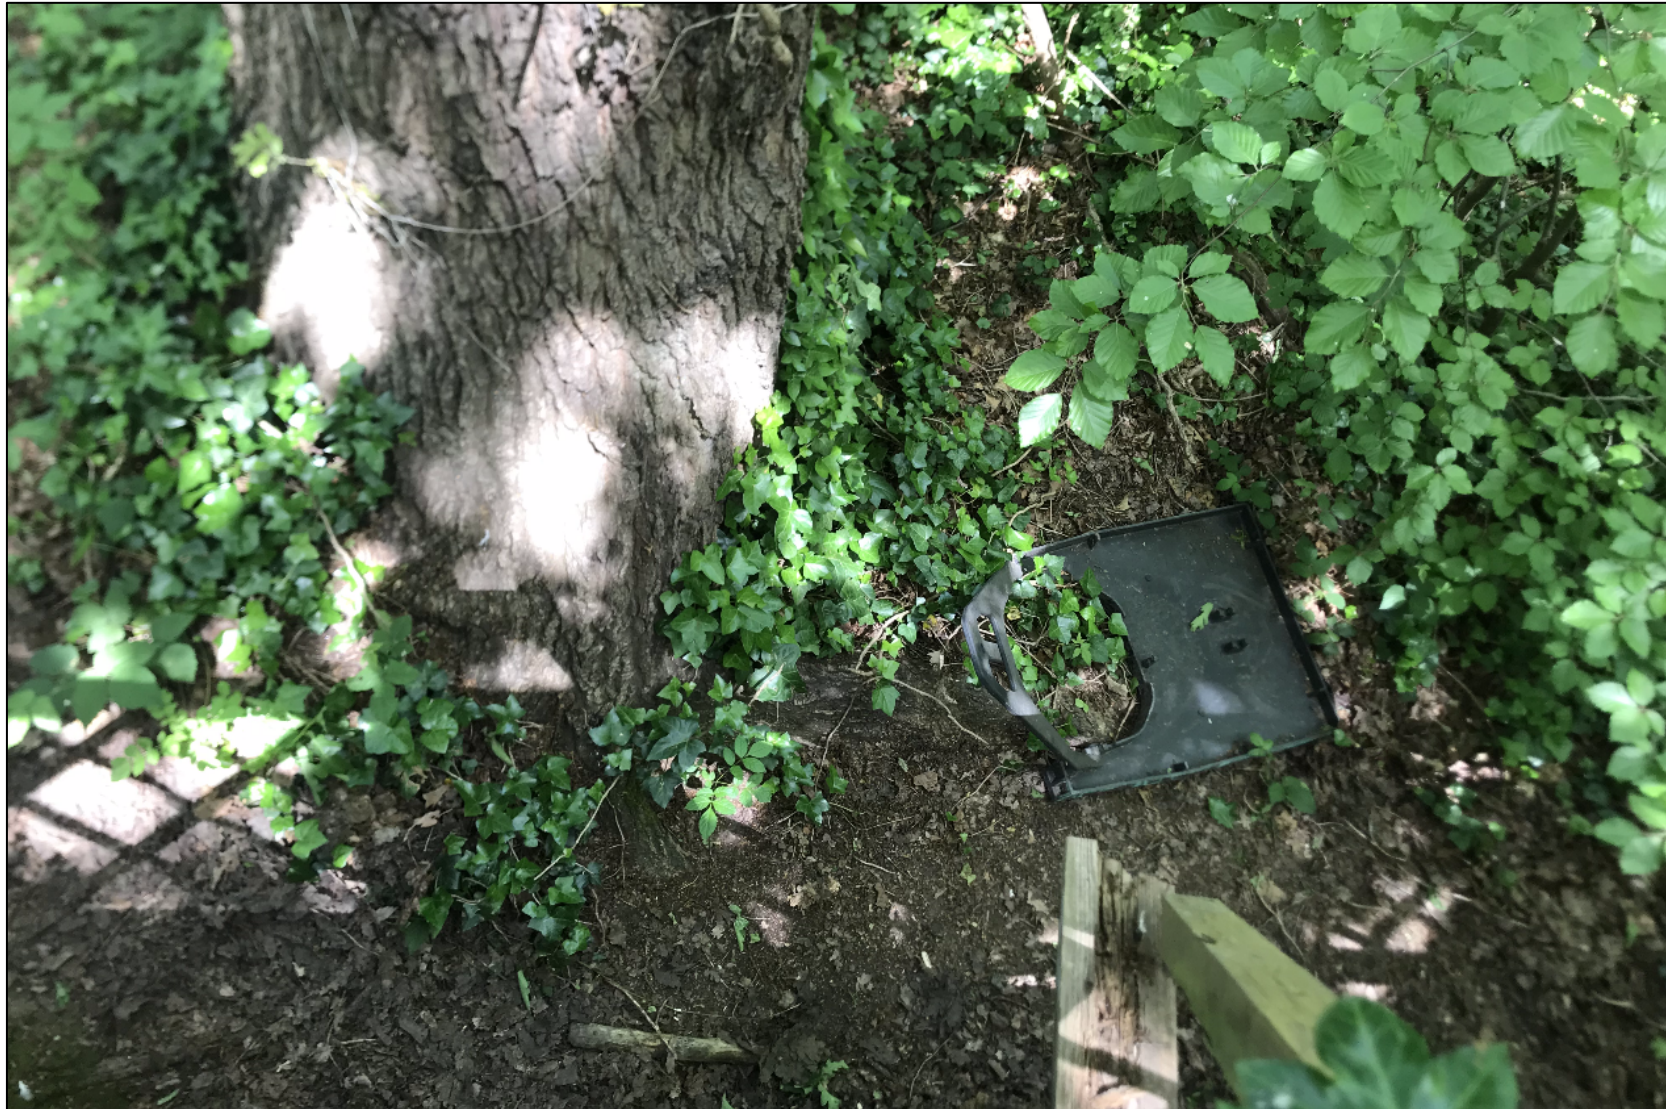
Photograph 3: Root architecture again trending away from abutment
