London Borough of Southwark

Dulwich Junction Site Visit Report

June 2022

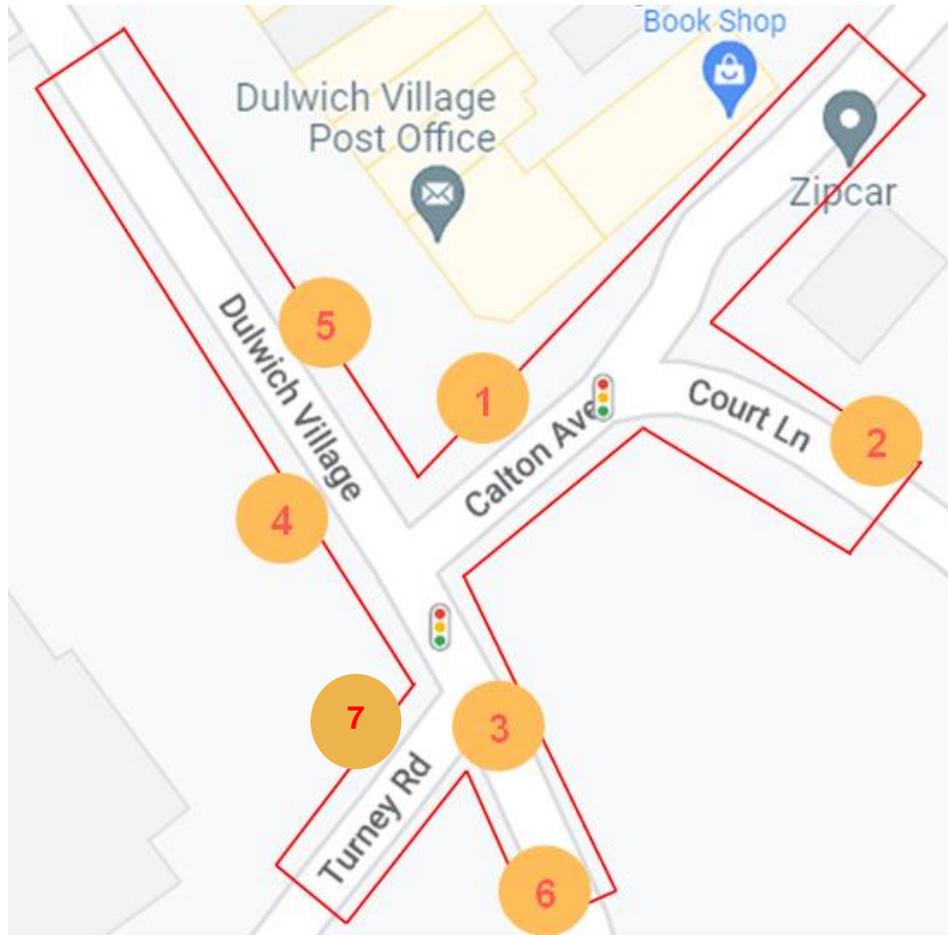
The areas covered during the site visit are marked below in red. The numbers marked on the map refer to specific issues identified in section three.

The numbers below relate to the numbers marked on the map showing roads covered during the site visit.

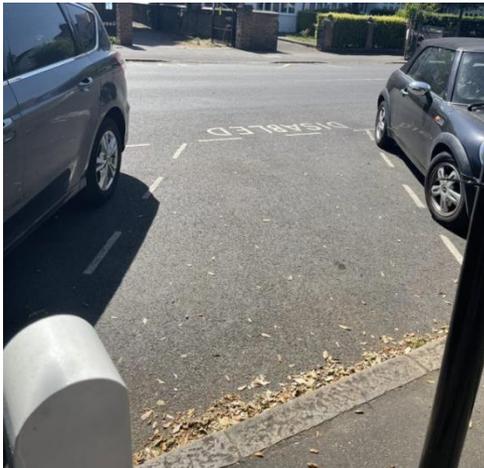
One car parking bay on this stretch of road was labelled as 'disabled'. However, the bay appeared to be the same width as the other parking bays, without any crosshatching at either side to provide extra space. Additionally, there is no dropped kerb to move from the parking space onto the pavement.

Photo 01 shows a parking bay that has the word 'Disabled' written by it, but no associated infrastructure to support disabled drivers or passengers.

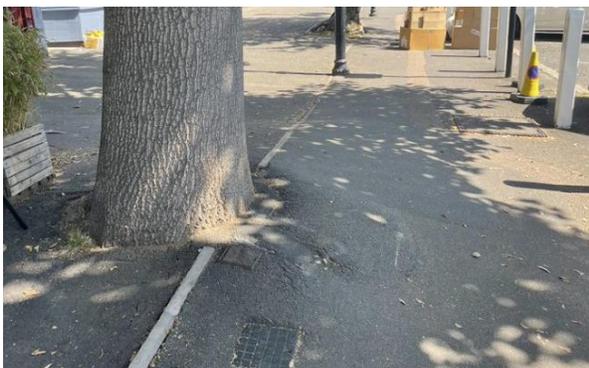
There are trees growing under the pavement and lifting it up, creating a slope. This is difficult for wheelchair users and visually impaired people to navigate.

Photo 02 shows tarmac around a tree root that is uneven and creates a slope. The photo is taken outside 37-39 Dulwich Village.

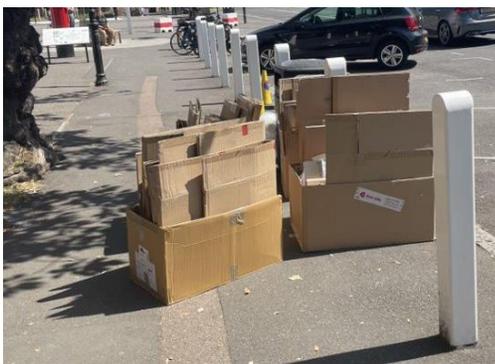
There are white bollards in front of the parking bays, with clutter, rubbish and recycling leaning against them. This street clutter has reduced the usable pavement width and creates a barrier for visually impaired people and wheelchair users to navigate.

Photo 03 shows boxes that have been piled up across the pavement.

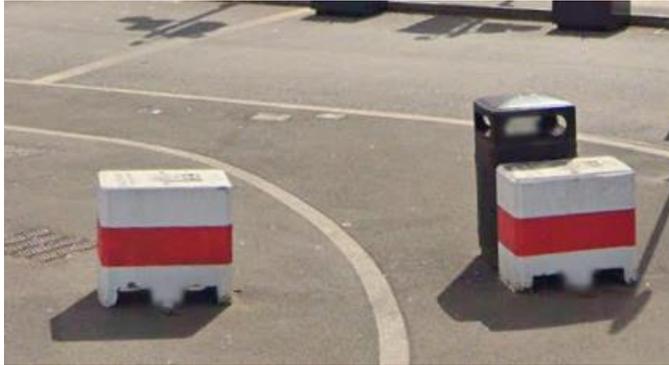
There are white and red blocks at the corner of the junction with Calton Avenue which appear to be anti-car measures, but their purpose is not clear. They have sharp edges and are placed across the pavement where visually impaired people may walk into them. There is sufficient space between them for wheelchair users to manoeuvre through.

Photo 04 shows the white and red blocks. Image taken from Google Maps.

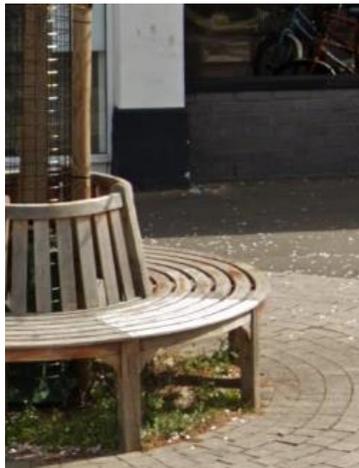
The seating outside the Post Office was welcomed as providing a helpful meeting point and rest space. However, the seating lacks arm rests which some people would find helpful to support sitting and standing.

Further, it does not have contrast to differentiate it from the similar colour of the paving, creating a barrier for visually impaired people.

Photo 05 shows the circular bench outside Dulwich Village Post Office. Image taken from Google Maps.

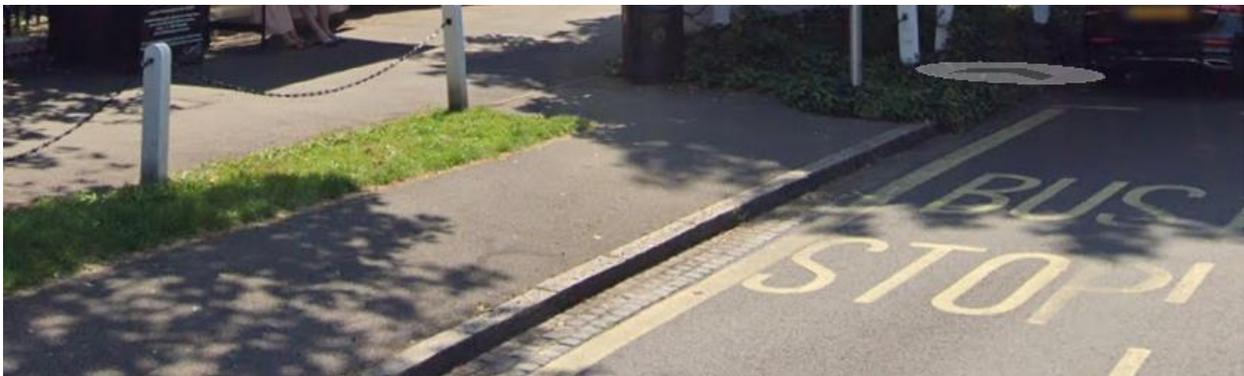
The bus stop consists of a post and flag at the kerbside, and a bus passenger shelter located some distance away at the back of the pavement. The distance between the two may pose a barrier for people with mobility impairments who may be seated at the shelter and may take longer to walk to the bus post when a bus arrives. The boarding/alighting area is quite narrow. If a bus ramp isn't deployed in the appropriate place, wheelchair users may have to wheel into grass to do a sharp turn to be able to get onto/off the bus.

One side of the bus boarding/alighting area is cordoned off through the placement of white bollards with spiked chains running between them at knee height. The purpose of these is unclear, and the chains could be a trip hazard for visually impaired people such as white cane users who will not pick up on the hazard at pavement level.

Photo 06 shows the bus stop boarding and alighting area, with the chains and bollards next to it. Image taken from Google Maps.

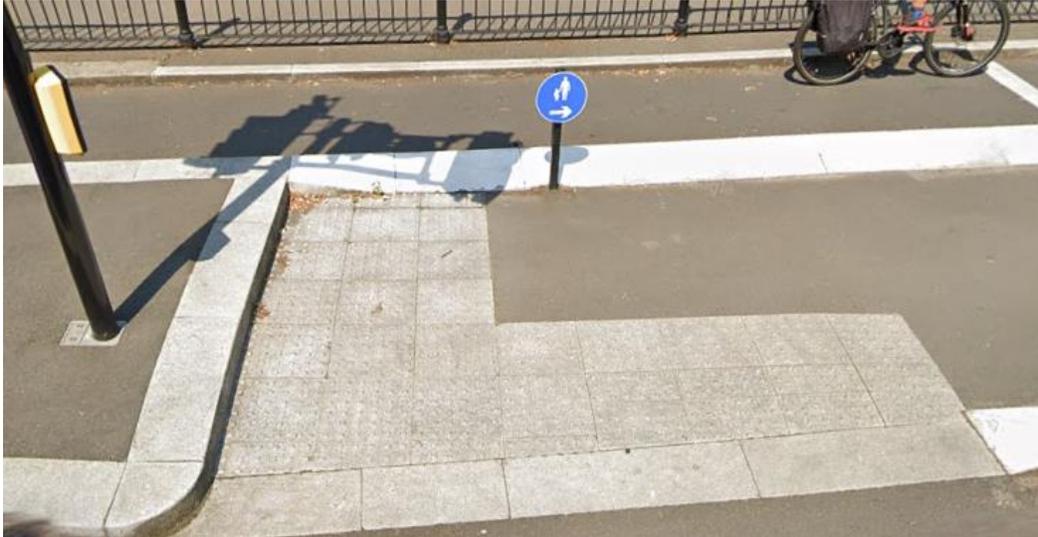
There is 'L' shaped tactile paving at two junctions of the crossing, however this is of a similar colour to the surrounding pavement. Best practice recommends use of red tactile paving at controlled crossings.

On the North side of the road there is a pedestrian island before the path crosses a cycle lane, which again is wide but not deep, creating a tight corner for people to navigate.

Photo 07 shows the traffic island mid-way across the crossing on Turney Road. Image taken from Google Maps.
