Bermondsey Street Conservation Area The Character and Appearance of the Area

Bermondsey Street (south)

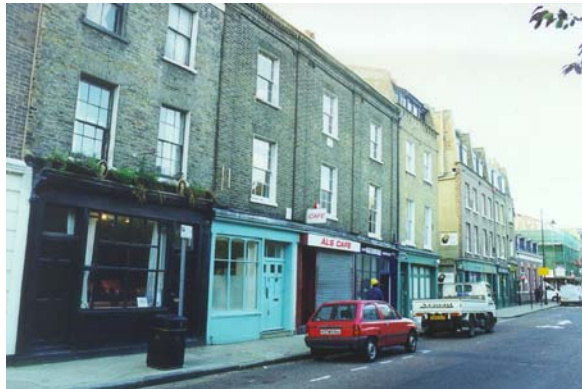
Figure 21 124-132 Bermondsey Street: early 19th century houses converted to shops and now listed. The picture shows the importance of the original cornice line and the impact of modest roof extensions on neighbouring buildings.

- 3.2.8. Between Leathermarket Street and Lamb Walk the buildings provide a very consistent street frontage in a group centred on listed buildings at nos. 124-132 (dated 1828). Originally houses, they have a three-storey cornice line and simple shop fronts linked by a common fascia line. The windows of the upper floors create a simple unifying rhythm. Other buildings in the block have been extended to a mansard storey set slightly back but retain the dominant line of the cornice. New residential development at 134 to 140 continues the line of the shop fronts as a stuccoed ground floor elevation.

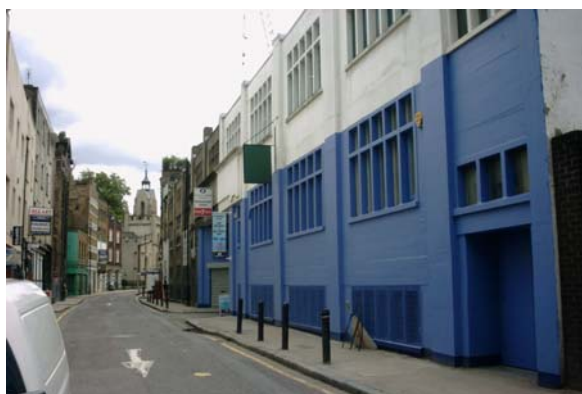
Figure 22 Looking south to St. Mary Magdalene, showing concrete buildings at 156-170 Bermondsey Street, with repaired and painted façades.

- 3.2.9. South of Lamb Walk, the yard to a large modern warehouse interrupts the continuity of the western street façade. It is re-established by the frontage of early 20th century concrete buildings at 156-170, but the character of the buildings at street level is harsh, with lower ground floor windows on the level of the pavement necessarily protected by mesh screens, and upper floor windows well above head height. The original surface was badly stained, but the northern half of the buildings have been painted brightly, which lifts its heavy appearance and brings a little more vitality to the street scene.

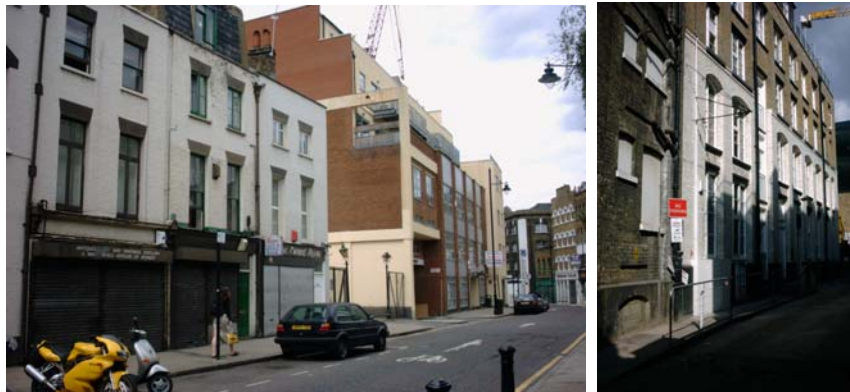
Figure 26 (left) New development at 194 to 204 Bermondsey Street dominates its historic neighbours at 210-214, despite a stepped front elevation.

Figure 27 (right) Some industrial buildings in yards behind Bermondsey Street are large scale (Newham's Row).

- 3.2.13. Southern Bermondsey Street is experiencing significant pressure for renovation and redevelopment. This is most noticeable at the edge of the Conservation Area in sites and yards behind the main building frontages, e.g. in Newham's Row and behind 156 to 170 Bermondsey Street. Some existing industrial buildings in these locations are large (see Figure 27), but it is important that these are not taken as precedence for over-development for other uses. Many parts of the main street frontage are only three storeys, and in this context, examples such as the new block at 194-204 Bermondsey Street whose flank elevation dominates the buildings around it.

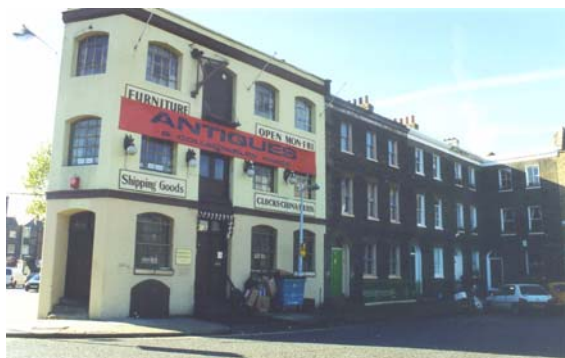
Figure 33 South side of Bermondsey Square: the houses are all that remain of the original square, and the warehouse was added to finish the block neatly when Tower Bridge Road was broken through.

- 3.3.1. The characteristics of Bermondsey Square are its openness and the fragmented nature of its street surfaces. Of the original urban form, only the south west corner of the square remains, at nos. 2-5. These four early 19th century houses indicate how the corner of the square was neatly turned, carrying through the simple detail and proportion of the brick façade. The group retains iron railings to the front areas, which are important in illustrating the street character of the original square before it was lost by the construction of Tower Bridge Road and later 20th century damage and redevelopment. The small oval garden at roughly the centre of the original square is a token of its former urban character, and the enclosing railings and neatly clipped privet hedge are part of this earlier setting.
