#### 4.3. Sub Area 1 - Bermondsey Street south

4.4. Sub Area 2 - Grange Walk and Bermondsey Square

#### 4.5. Sub Area 3 – Weston Street area

#### 4.6. Sub Area 4 - Tower Bridge Road area

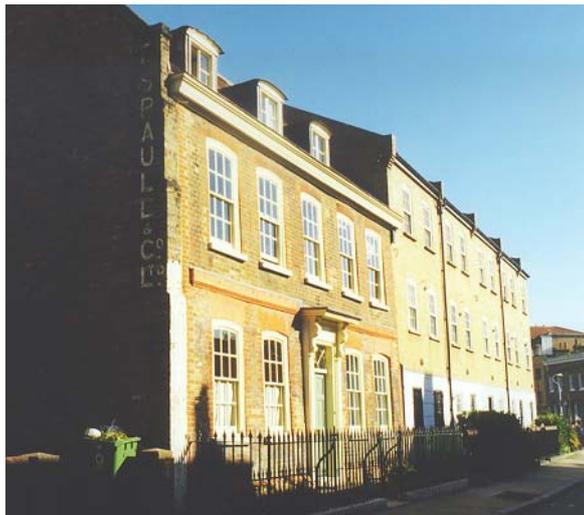
Figure 55 *67 Grange Walk: Grade II\* listed house on the north side of the street.*

- *15-32 Grange Walk*: No. 15 is the former Girls Charity School and is a strong corner building; the remainder of the group is a very consistent early 19th century brick 2 storey terrace. The eastern end has a pair of stucco houses, and the former infants school, now residential (Grange Walk Mews).
- *67 Grange Walk*: the only remaining historic building on the north side of the street, and important in representing the original alignment of the street frontage, which is followed by new houses at 1-5 Melford Court. A fine 18<sup>th</sup> century house, it is Grade II\* listed.

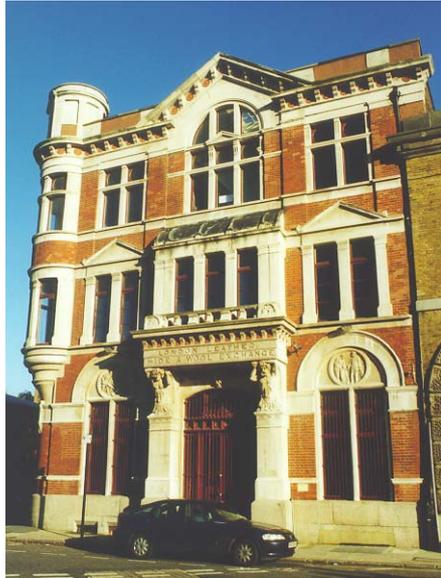
Figure 57 *The London Leather, Hide and Wool Exchange: George Elkington & Sons, 1878.*

- *Leathermarket including 11-17 Leathermarket Street*: landmark corner buildings (see below). As a group, including the Leather Exchange pub, the buildings provide very important definition of both Leathermarket Street and Weston Street. The block closes vistas along both streets, and the architectural detail of the corner, in particular, with its red brick and Portland stone turret, is a focal point in these vistas. The detail and signage of the pub and its corner position also provide important punctuation of the Leathermarket Street vista.

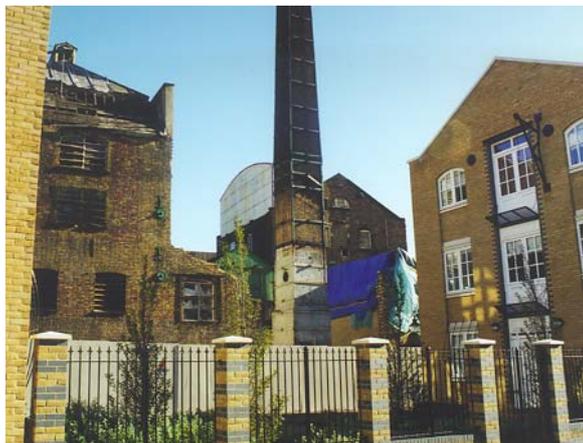
Figure 58 *Sarsons' site viewed from Brunswick Court, showing the engine house chimney and industrial features that should be preserved.*

- 170167-169 Tower Bridge Road (Roper Lane): 2 storey factory buildings, forming 20th century frontage to early 19<sup>th</sup> century listed Vinegar Brewery buildings. Provides enclosure of treed street space formed by Roper Lane and Tower Bridge Road in front of the railway bridge. A new corner building by Weston Williamson at 35-45 Tanner Street now forms a very effective part of the block. The engine house chimney is a

very visible element of the historic works complex, otherwise largely hidden from view behind street frontages.

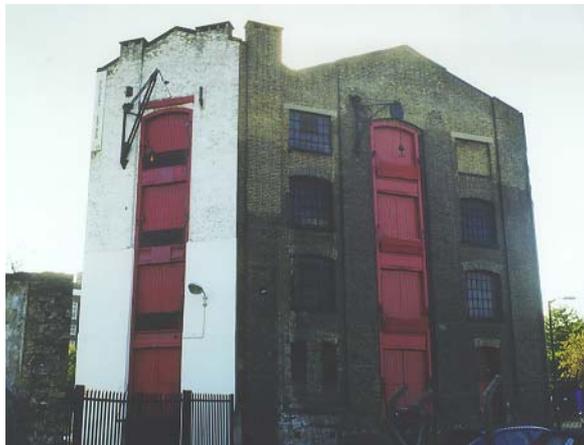
Figure 60 Vinegar Yard warehouse: any renovation should also consider the yards and spaces around it, which are currently used for car parking.

- 9-17 Vinegar Yard: 4 storey warehouse and surroundings in need of renovation;

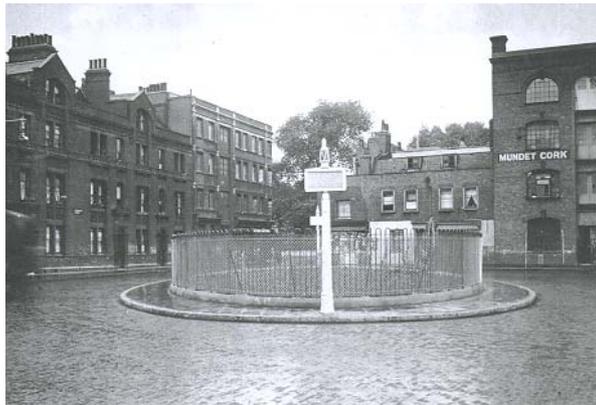
*Figure 61 North side of Bermondsey Square, 1935, showing enclosure between the square and Abbey Road, with glimpses to St. Mary Magdalene churchyard.*

- 4.6.18. It may be possible to re-introduce buildings to provide better containment of the space, particularly on the Tower Bridge Road side. Full restoration of the original extent of buildings around the square would probably be overdevelopment, and any loss of open space would have impacts on the operation of the New Caledonian Antiques Market.
