C0347 Cox's Walk Footbridge Assessment Report

London Borough of Southwark

Project Reference: 60493385
Project Number: C0347
60493385-C0347-REP-0003-A

23 May 2018

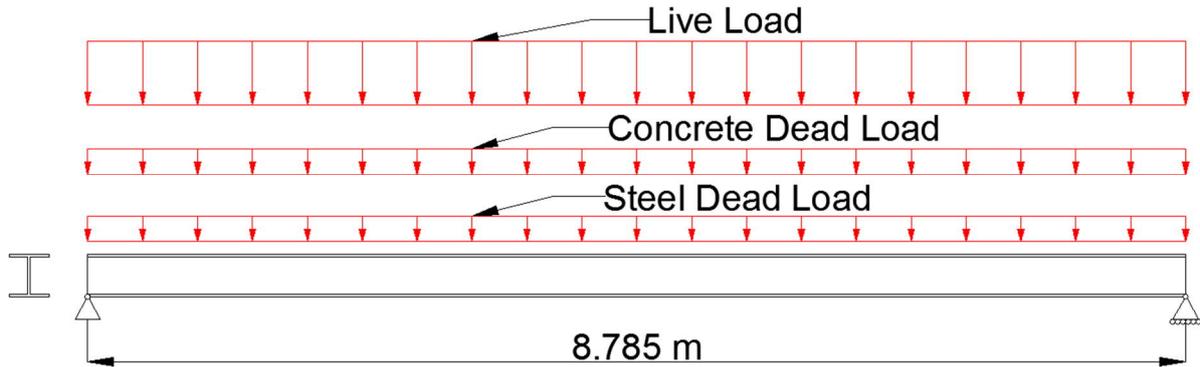
Figure 2: Loading to Centre Span Steel Beam

The steel beam was analysed with the 5mm section loss to in the inside of each flange observed in the Special Inspection Report (document: 60493385-C0374-REP-0002).

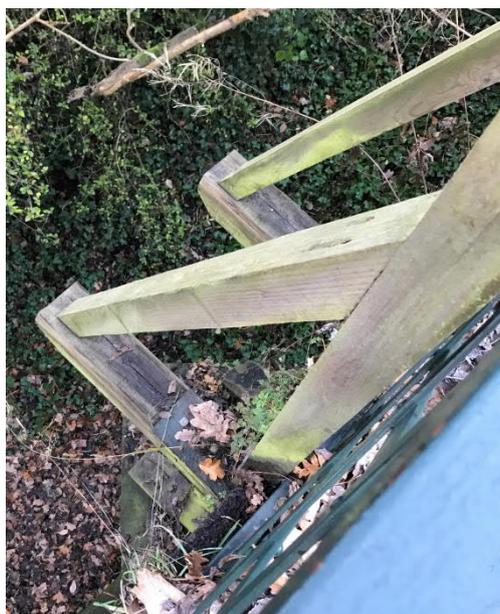
Figure 11: Photo of lateral triangular timber frames

The bases of the timber frame are connected to the abutments and piers via pinned supports. The main horizontal timber beams are fixed in the transverse direction by bolts to the outer steel beams. The ends of the parapets are fixed transversely by triangular timber frames.
