ARBORICULTURAL IMPACT ASSESSMENT REPORT FOR:

Cox's Walk Footbridge

Sydenham Hill Wood

Ref: SFO/CWF/AIA/01b

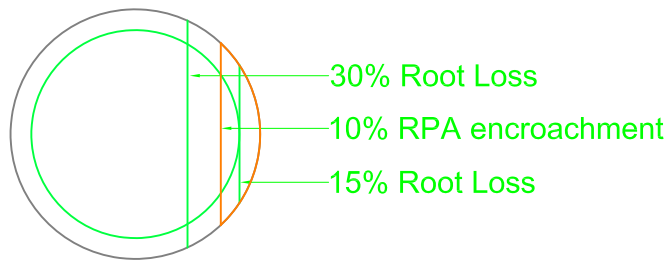
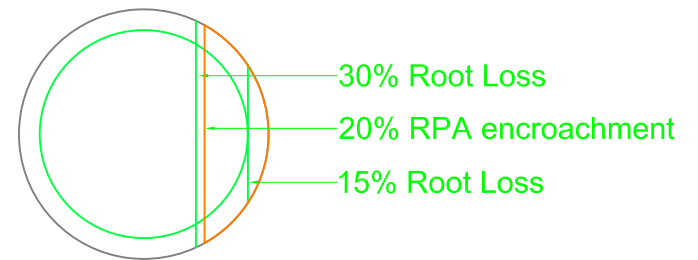
Figure 5a: approximate correlation between RPA encroachment and actual root loss on a free-grown tree of 5m RPA radius (after Thomas (2014))

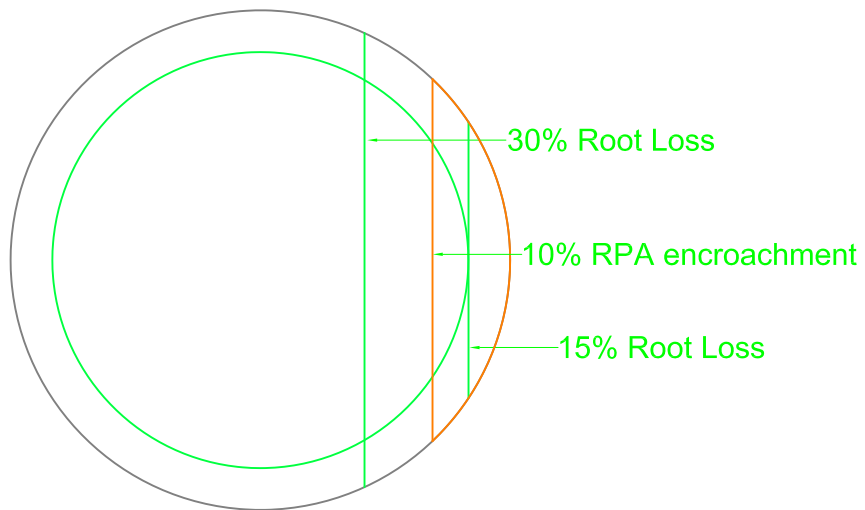
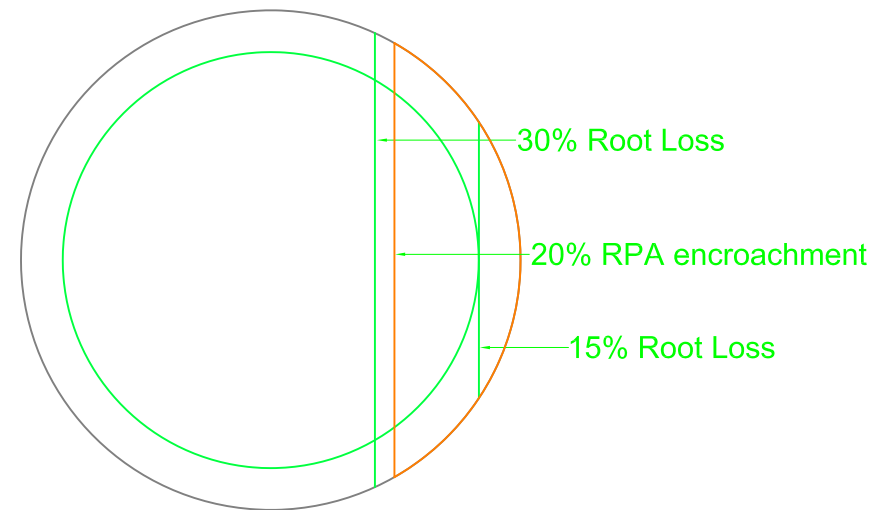
Figure 5b: approximate correlation between RPA encroachment and actual root loss on a free-grown tree of 10m RPA radius (after Thomas (2014))

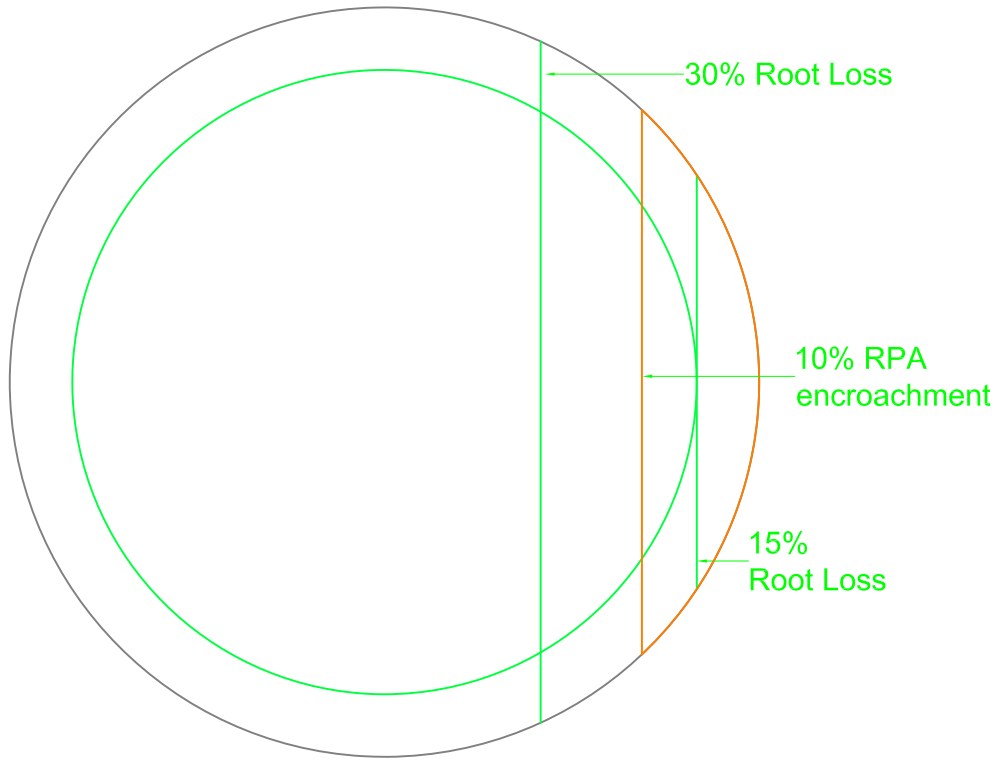
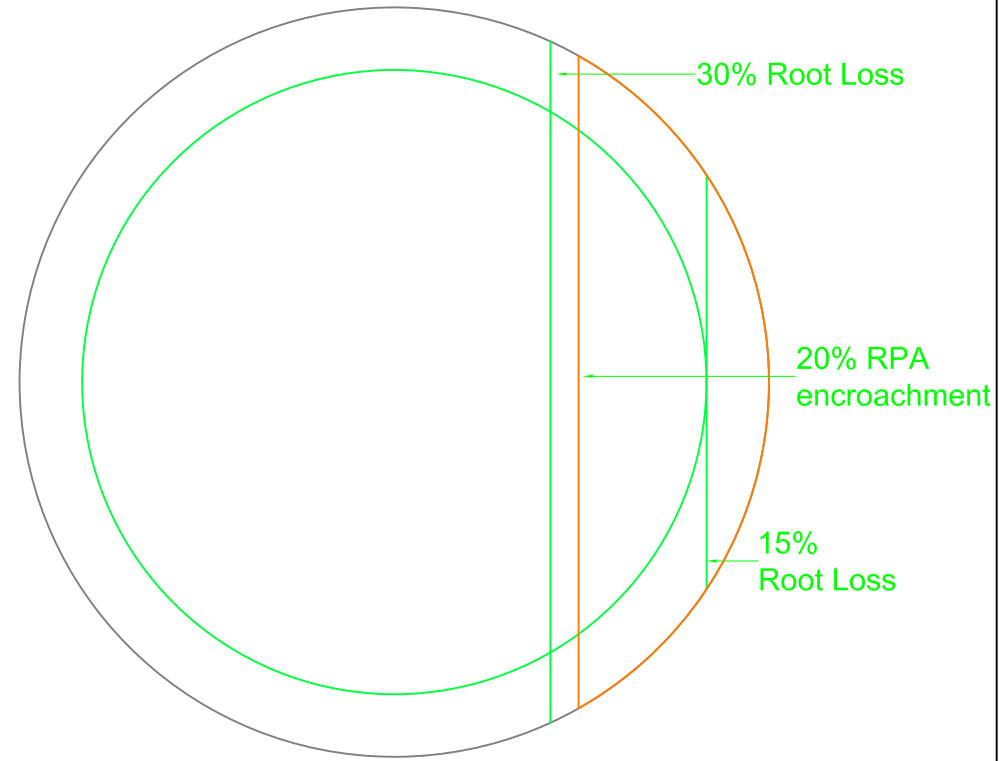
Figure 5c: approximate correlation between RPA encroachment and actual root loss on a free-grown tree of 15m RPA radius (after Thomas (2014))
